# Inspection Report

**DP Inspections LLC**

<b>Date:</b> 2/15/2023	<b>Time:</b> 08:30 AM	<b>Report ID:</b> 1 [REDACTED]
<b>Property:</b> [REDACTED] Mount Pleasant SC 29466	[REDACTED]	<b>Real Estate Professional:</b> [REDACTED]

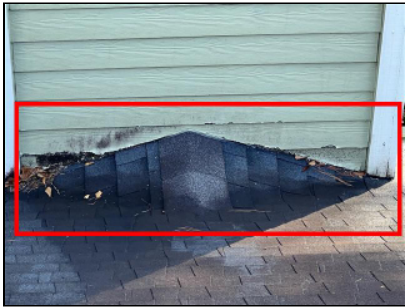
1.1 Item 1(Picture)

**1.1** The base of the chimney, around the cricket flashing, has severe moisture damage. In addition, there is wood rot on the trim, and the siding has moisture damage. It appears this area holds water, and the cricket flashing may need to be larger, or another flashing may need to be installed. I recommend further evaluation by a qualified professional and correct it as needed.

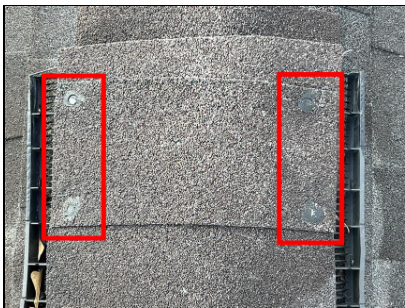
1.2 Item 1(Picture)

**1.2** The nail heads on the ridge caps are exposed. Exposed nail heads can increase the chance of water penetration into the house. I recommend having the nail heads sealed with a roof sealant.

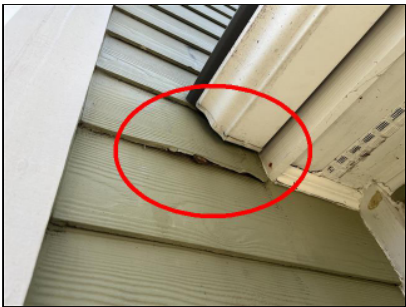
2.0 Item 1(Picture)

**2.0 (1)** There is moisture damage on the siding below the gutter on the chimney. The damage is most likely caused by water overflowing the gutters. I recommend further evaluation by a qualified professional and correct it as needed.

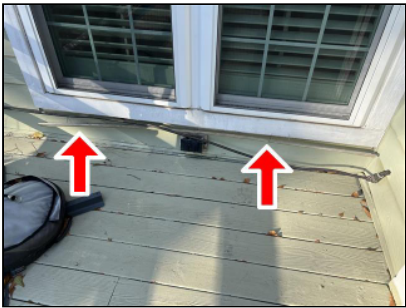
2.0 Item 2(Picture)

**2.0 (2)** A piece of trim has come off under the window at the back of the house. I recommend repair by a qualified professional.

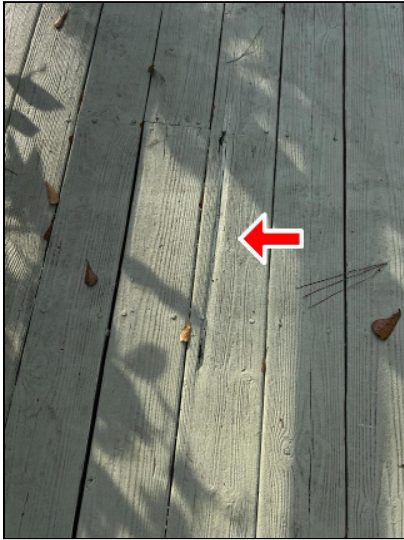
2.3 Item 1(Picture)

**2.3** Several boards on the back deck have wood rot. I recommend repair by a qualified professional.

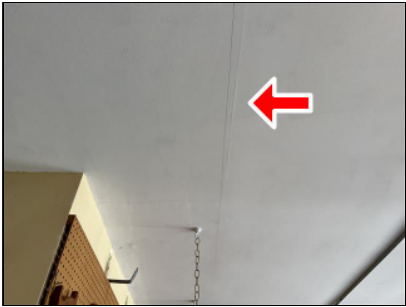
3.0 Item 1(Picture)

**3.0** There is a settlement crack running through the garage ceiling. There are several reasons for settlement cracks, with the most common being house settlement and the studs' movement due to expanding and contracting. This is considered cosmetic. Repair if desired.

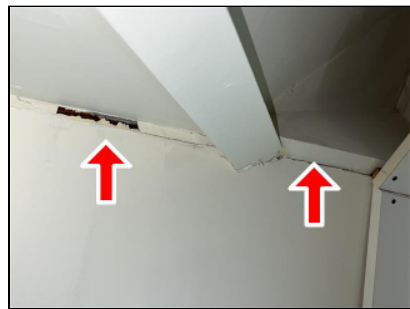
4.0 Item 1(Picture)

**4.0** There are a few settlement cracks on the ceiling in the FROG. There are several reasons for settlement cracks, with the most common being house settlement and the studs' movement due to expanding and contracting. This is considered cosmetic. Repair if desired.

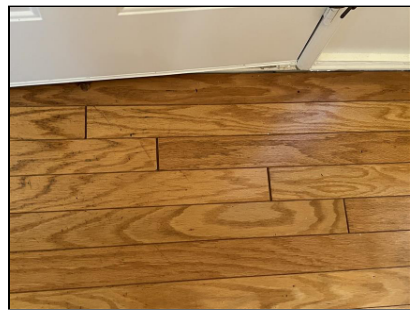
4.2 Item 1(Picture)

**4.2 (1)** The floors in the foyer and living room have wide gaps between several boards. Gaps in wood floors are normal and occur when the wood loses its moisture content. Several factors can be the cause, such as the flooring being installed during periods of higher humidity and during the winter; when the heat is on, the gaps appear. However, the large gaps are only showing up in theses two areas. I recommend further evaluation by a qualified flooring professional and correct it as needed.

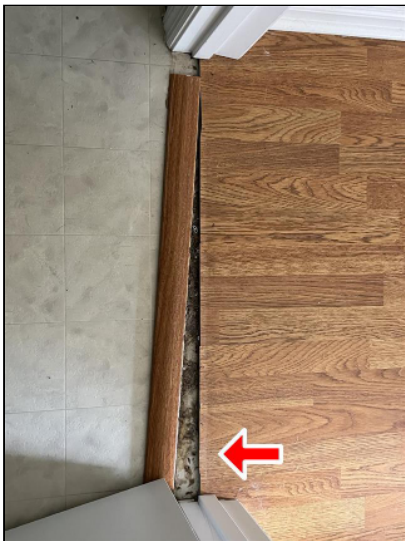
4.2 Item 7(Picture)

4.2 (3) The threshold to the laundry room is not attached. I recommend repair by a qualified professional.

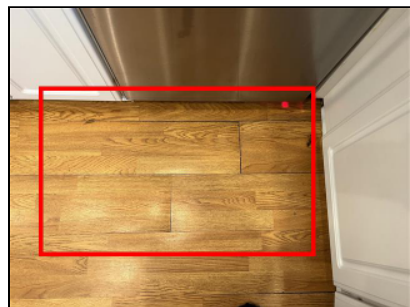
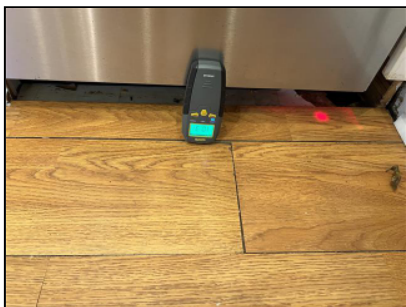
4.2 (4) The flooring in front of the dishwasher has moisture damage. At one time, the dishwasher leaked and damaged the floor. This section will most likely need to be replaced. I recommend repair by a qualified professional.

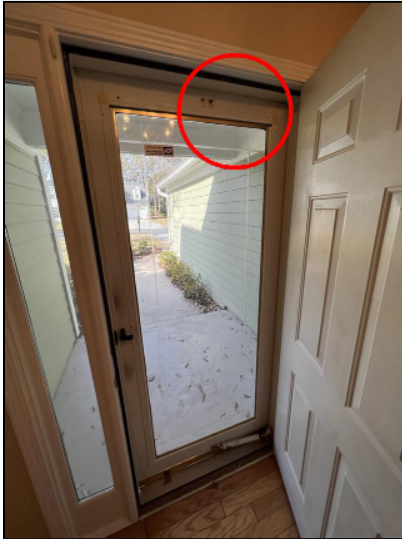
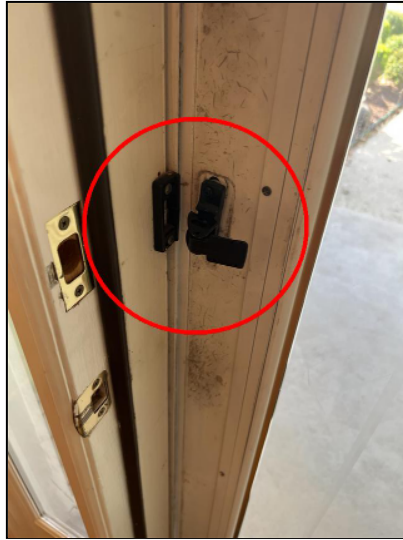
**4.5** The front door is missing the pneumatic opener at the top, and the door handle does not engage the striker. I recommend repair by a qualified professional.

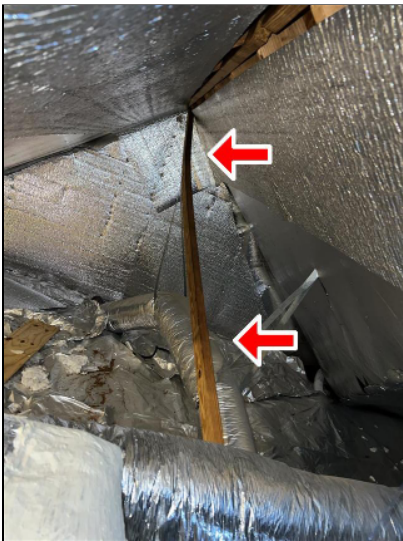
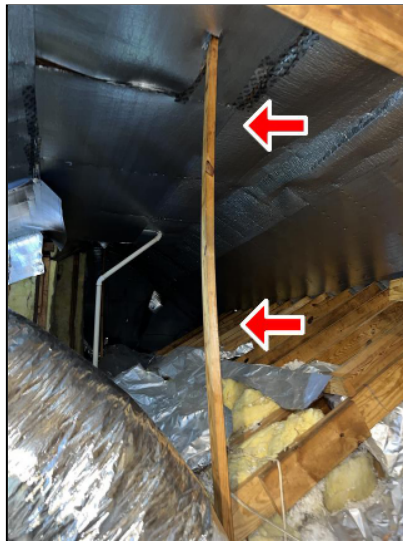
**5.5 (1)** There are a couple of 2x4s in the attic that are bowing. This could be from excessive weight or humidity in the attic. I don't know how or if this affects the roof's structure. I recommend further evaluation by a qualified professional and correct it as needed.

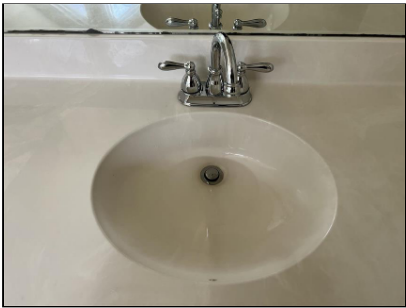
6.0 Item 1(Picture)

**6.0** The master bathroom sink (right) drained very slow. Typically, the cause of a slow-draining bathtub is a clog that is restricting water flow. Clogs are usually made up of knotted hair, dirt, grease, and/or soap. I recommend further evaluation by a qualified professional and correct as needed.

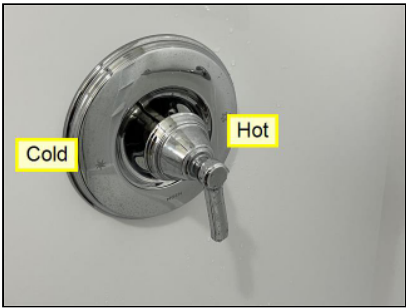
6.1 Item 1(Picture)

**6.1** (1) The hot and cold are reversed in the guest bathroom shower. Cold water should always be on the right side of the faucet and hot on the left. This is an industry standard throughout North America. I recommend repair by a qualified professional.

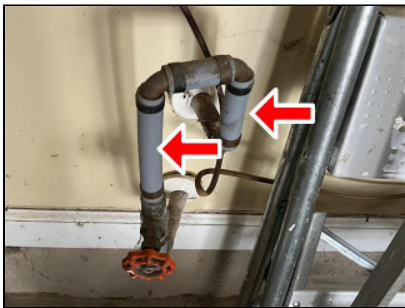
6.1 Item 2(Picture)

**6.1** (2) The plumbing supply in the home contains polybutylene (PB) with copper crimp rings. Polybutylene piping expands and contracts a good deal and the abrasive effects can be damaging. I did not observe any leaks at exposed joints I could see during the inspection. However, given the history of polybutylene piping I recommend you consider having a licensed plumber further evaluate the system.

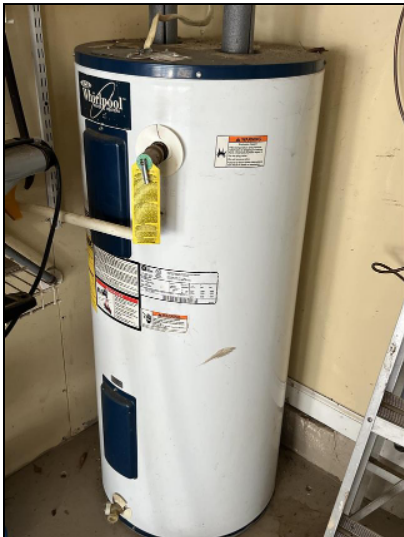
6.2 Item 1(Picture)

**6.2** The water heater's manufacture date is 2008. Based on the manufacturer's suggested service life, the life expectancy of a water heater is about 8 to 12 years. The water temperature was taken at the fixtures, and the highest temperature I could get was 115 degrees. This could be as simple as they have the temperature turned down at the water heater. The EPA does recommend 120 degrees because it is hot enough to stop diseases and not hot enough to cause scalding. Additionally, the top connections are starting to rust. Once they rust, the connections could burst. Due to the age of the water heater, and the rust, I would recommend replacing the water heater.

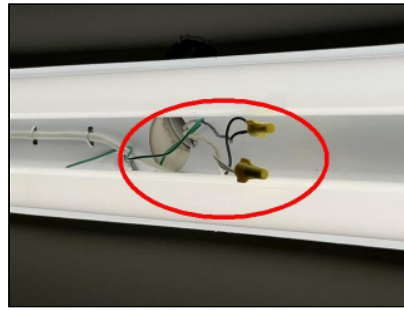
7.3 Item 4(Picture)

**7.3 (3)** There are exposed wires in the closet light in the guest bedroom. Exposed wires are a safety hazard. I recommend repair by a qualified professional.

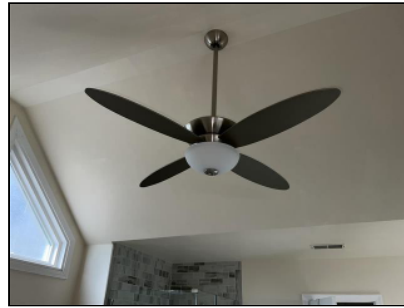
7.3 Item 5(Picture)

**7.3 (4)** I could not find the remote to test the fan in the master bathroom. I recommend asking the seller for the remote and testing it before moving into the house.

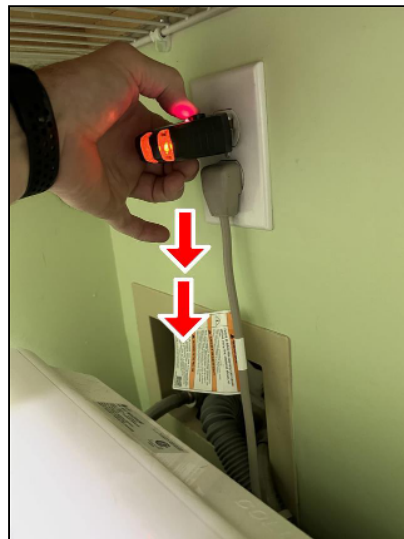
7.4 Item 1(Picture)

**7.4** The outlet for the washing machine in the laundry room is within six feet of a plumbing fixture, and it is not GFCI protected. This is due to the age of the house. As an upgrade, I would recommend adding a GFCI outlet.

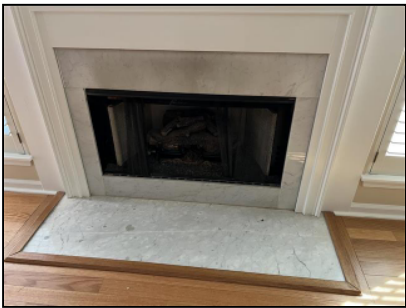
8.7 Item 1(Picture)

**8.7** The fireplace was not tested, as there was no propane tank.

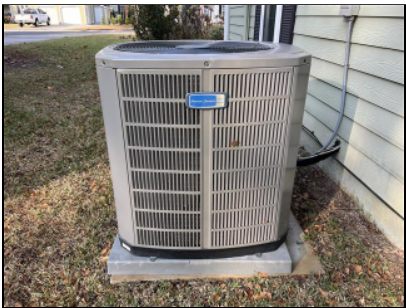
8.8 Item 1(Picture)

**8.8 (1)** The manufacture date of the HVAC is 2021. The average life expectancy of an air conditioner or heat pump in South Carolina is 15-20 years. However, attempts were made to turn on the HVAC to test the air conditioning, but it would not turn on. I recommend further evaluation by a qualified professional and correct it as needed.

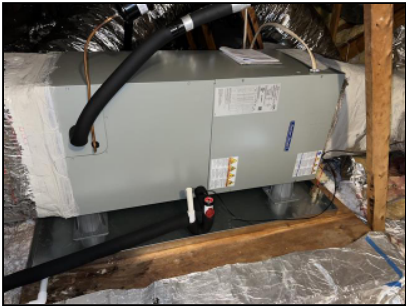
8.8 Item 5(Picture)

**8.8 (2)** The air handler in the attic is missing the seismic straps. Seismic straps are designed to hold the air handler in place during an earthquake so no damage is done to the lines. I recommend adding seismic straps and securing the air handler to the structure.

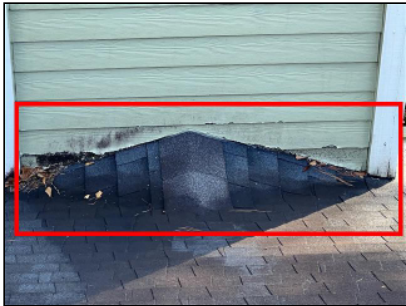
1.1 Item 1(Picture)

The base of the chimney, around the cricket flashing, has severe moisture damage. In addition, there is wood rot on the trim, and the siding has moisture damage. It appears this area holds water, and the cricket flashing may need to be larger, or another flashing may need to be installed. I recommend further evaluation by a qualified professional and correct it as needed.

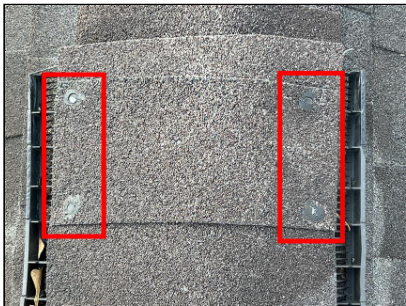
1.2 Item 1(Picture)

The nail heads on the ridge caps are exposed. Exposed nail heads can increase the chance of water penetration into the house. I recommend having the nail heads sealed with a roof sealant.

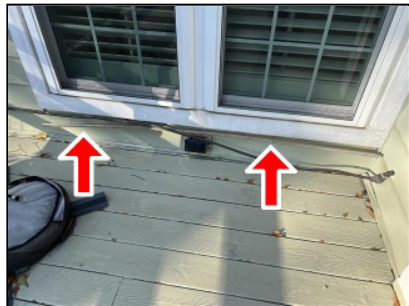
2.0 Item 2(Picture)

(2) A piece of trim has come off under the window at the back of the house. I recommend repair by a qualified professional.

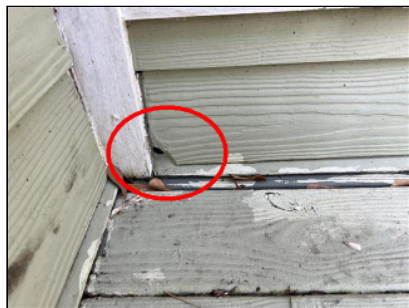
2.0 Item 3(Picture)

(3) Several pieces of the siding are damaged or have cracks. Cracks are usually caused by poor installation and should be sealed to prevent water intrusion. I recommend repair by a qualified professional.

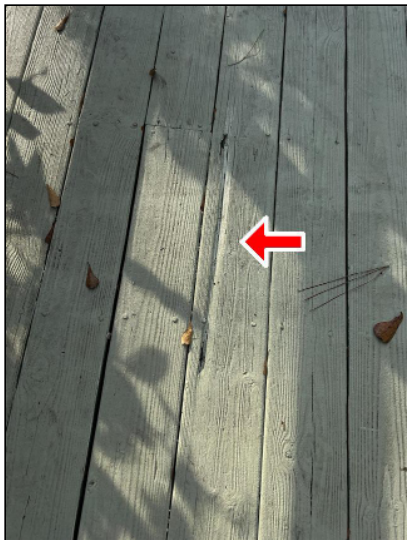
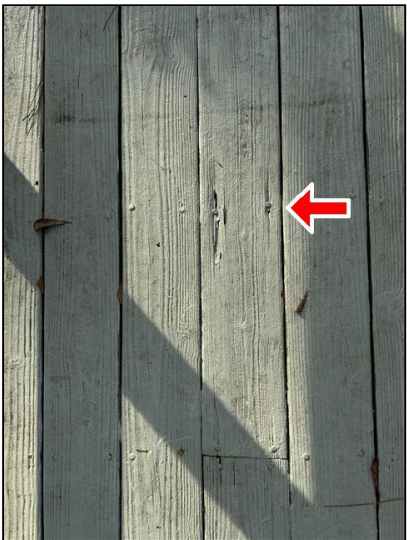
Several boards on the back deck have wood rot. I recommend repair by a qualified professional.

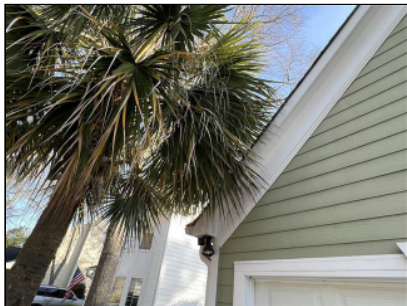
2.4 Item 1(Picture)

(1) The palmetto tree next to the garage is in contact with the roof and siding. The branches can damage the shingles and siding. I recommend having the trimmed away from the house.

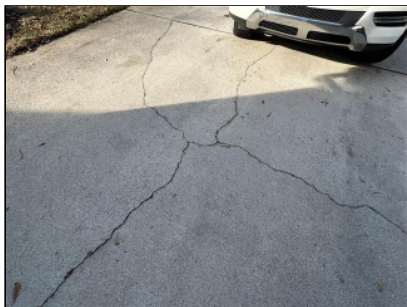
2.4 Item 2(Picture)

(2) The driveway is showing signs of settlement cracks. The most common reasons for settlement cracks in the driveway are settlement, shrinking, improper installation, and poor drainage. Small cracks are common and could be nothing to worry about. However, I recommend monitoring the floor, and if the cracks become bigger, I recommend repair by a qualified professional.

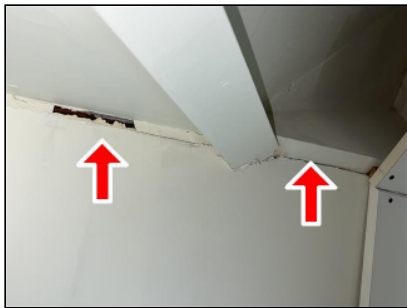
4.0 Item 1(Picture)

There are a few settlement cracks on the ceiling in the FROG. There are several reasons for settlement cracks, with the most common being house settlement and the studs' movement due to expanding and contracting. This is considered cosmetic. Repair if desired.

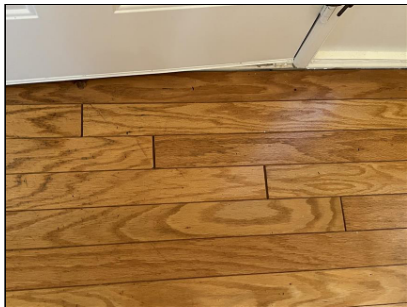
4.2 Item 1(Picture)

(1) The floors in the foyer and living room have wide gaps between several boards. Gaps in wood floors are normal and occur when the wood loses its moisture content. Several factors can be the cause, such as the flooring being installed during periods of higher humidity and during the winter; when the heat is on, the gaps appear. However, the large gaps are only showing up in these two areas. I recommend further evaluation by a qualified flooring professional and correct it as needed.

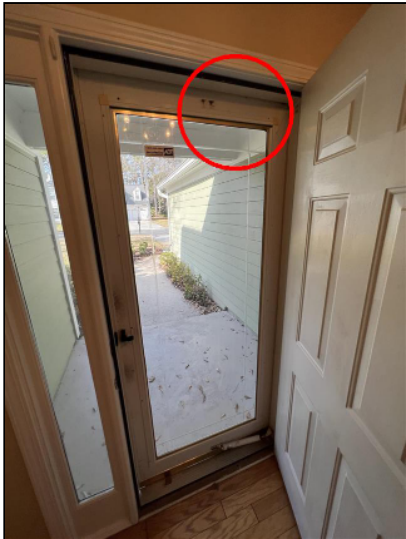
4.5 Item 1(Picture)

The front door is missing the pneumatic opener at the top, and the door handle does not engage the striker. I recommend repair by a qualified professional.

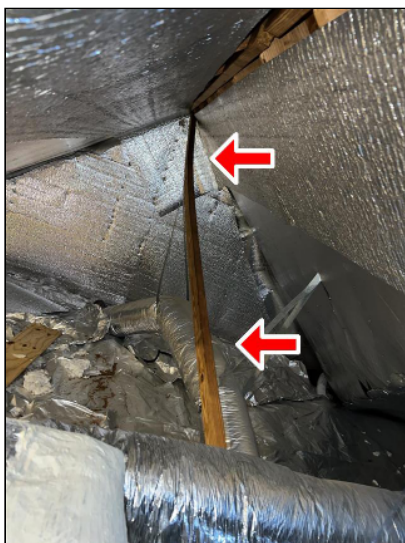
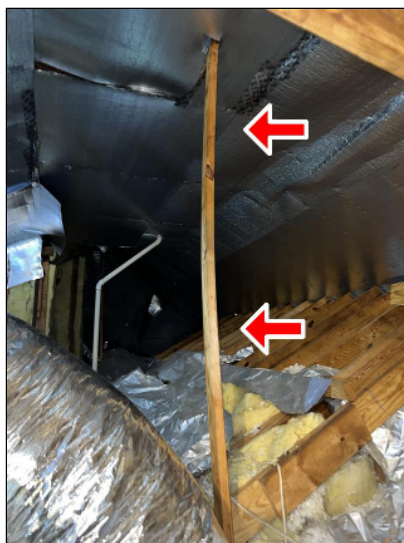
(1) There are a couple of 2x4s in the attic that are bowing. This could be from excessive weight or humidity in the attic. I don't know how or if this affects the roof's structure. I recommend further evaluation by a qualified professional and correct it as needed.

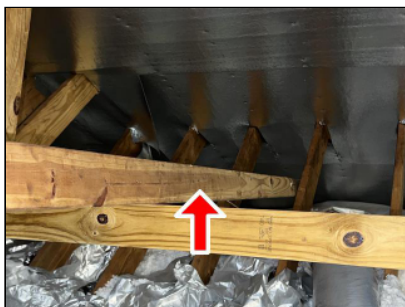
5.5 Item 3(Picture)

(2) One of the cross beams in the attic has pulled out and is no longer nailed in. I recommend repair by a qualified professional.

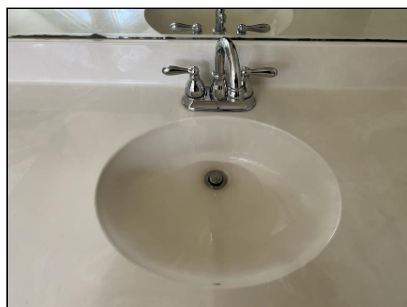
6.0 Item 1(Picture)

The master bathroom sink (right) drained very slow. Typically, the cause of a slow-draining bathtub is a clog that is restricting water flow. Clogs are usually made up of knotted hair, dirt, grease, and/or soap. I recommend further evaluation by a qualified professional and correct as needed.

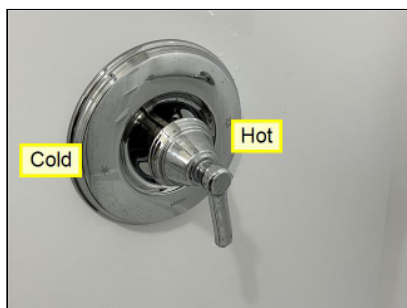
6.1 Item 1(Picture)

(1) The hot and cold are reversed in the guest bathroom shower. Cold water should always be on the right side of the faucet and hot on the left. This is an industry standard throughout North America. I recommend repair by a qualified professional.

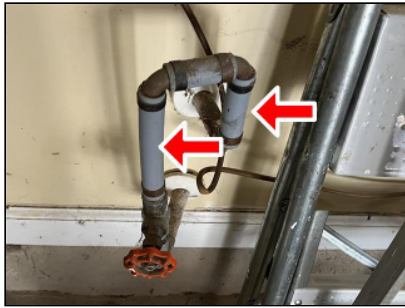
6.1 Item 2(Picture)

(2) The plumbing supply in the home contains polybutylene (PB) with copper crimp rings. Polybutylene piping expands and contracts a good deal and the abrasive effects can be damaging. I did not observe any leaks at exposed joints I could see during the inspection. However, given the history of polybutylene piping I recommend you consider having a licensed plumber further evaluate the system.

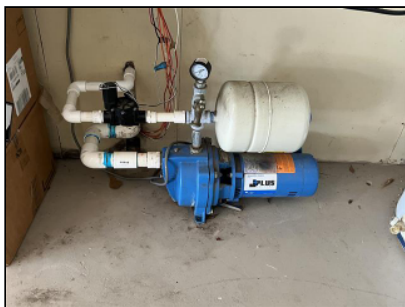
6.1 Item 8(Picture)

(3) The house does have a pump for well water. Our company does not test or operate well pumps. I recommend having a well and pump company test and service the pump before use.

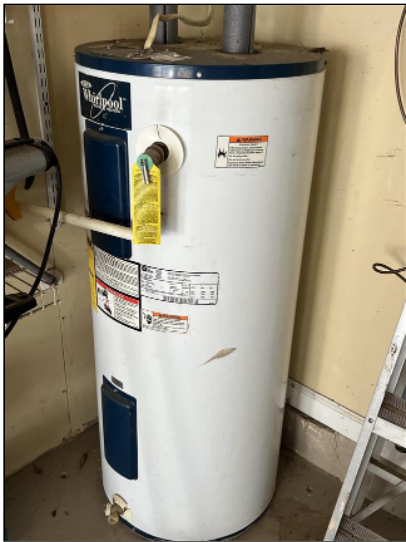
6.2 Item 1(Picture)

The water heater's manufacture date is 2008. Based on the manufacturer's suggested service life, the life expectancy of a water heater is about 8 to 12 years. The water temperature was taken at the fixtures, and the highest temperature I could get was 115 degrees. This could be a simple as they have the temperature turned down at the water heater. The EPA does recommend 120 degrees because it is hot enough to stop diseases and not hot enough to cause scalding. Additionally, the top connections are starting to rust. Once they rust, the connections could burst. Due to the age of the water heater, and the rust, I would recommend replacing the water heater.

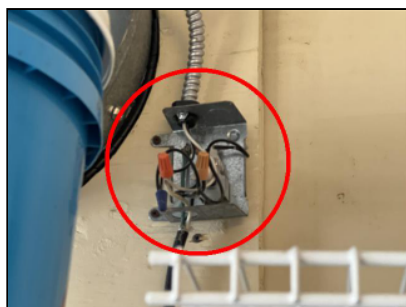
7.3 Item 3(Picture)

(2) The fan in the garage is missing the junction box, exposing the wires. Exposed wires are a safety hazard. I recommend repair by a qualified professional.

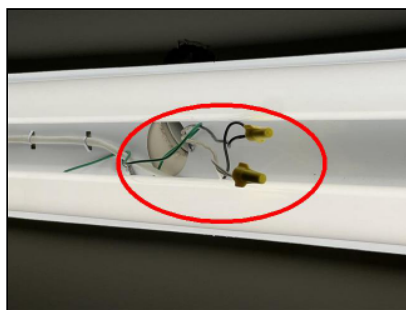
7.3 Item 4(Picture)

(3) There are exposed wires in the closet light in the guest bedroom. Exposed wires are a safety hazard. I recommend repair by a qualified professional.

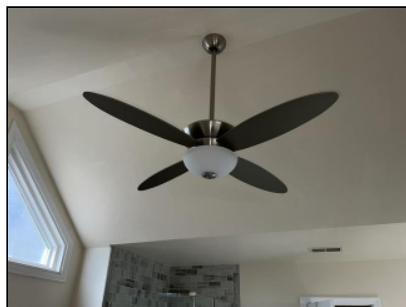
7.3 Item 5(Picture)

(4) I could not find the remote to test the fan in the master bathroom. I recommend asking the seller for the remote and testing it before moving into the house.

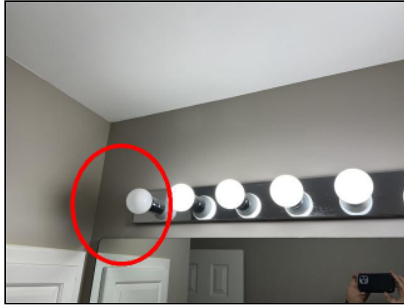
7.3 Item 6(Picture)

(5) The light in the guest bathroom is not working. This could be as simple as replacing a bulb. I recommend replacing the bulb. If that does not fix the issue, I recommend further evaluation by a qualified professional and correct as needed.

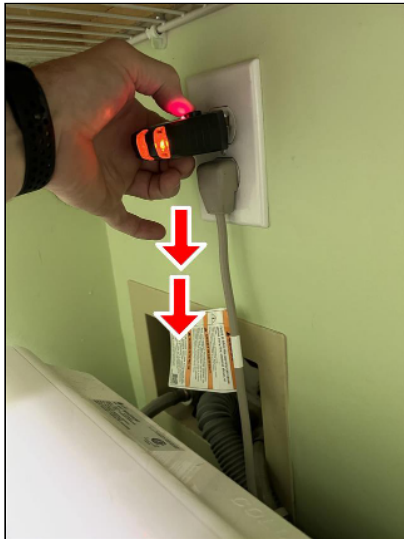
7.4 Item 1(Picture)

The outlet for the washing machine in the laundry room is within six feet of a plumbing fixture, and it is not GFCI protected. This is due to the age of the house. As an upgrade, I would recommend adding a GFCI outlet.

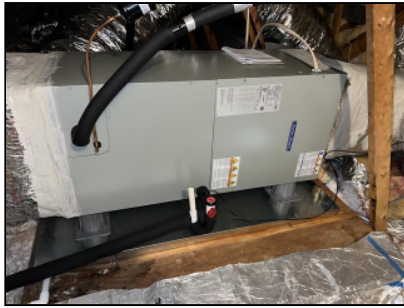
8.8 Item 5(Picture)

(2) The air handler in the attic is missing the seismic straps. Seismic straps are designed to hold the air handler in place during an earthquake so no damage is done to the lines. I recommend adding seismic straps and securing the air handler to the structure.
