Inspection Report

[Redacted]
Summerville SC 29486

DP Inspections LLC

1.0	Describe the stage of completion
1.1	Describe the methods used in this inspection
1.2	Were blueprints reviewed for this phase of inspection

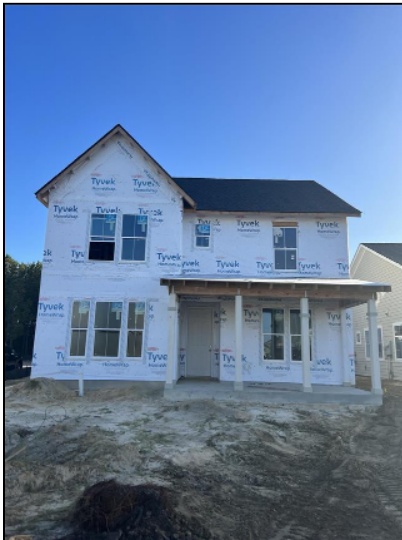
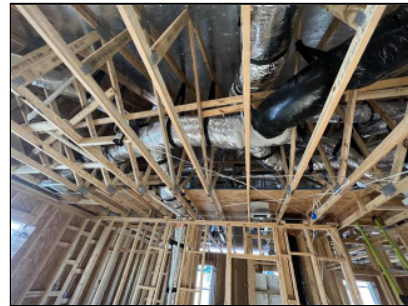
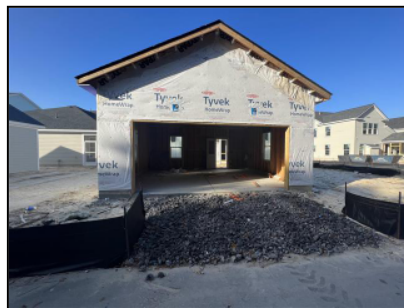
1.0 The home has been roughed in with plywood and exterior walls have backer board (underlayment) including a house wrap. The roof has been shingled. Plumbers, HVAC, and electrical contractors have completed their rough-in.

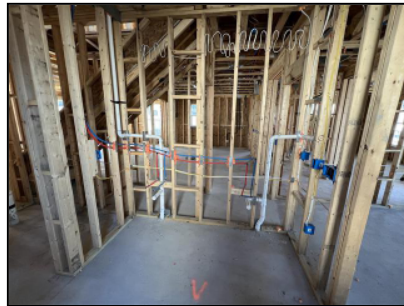
1.0 Item 2(Picture)

1.1 This inspection was performed visually. The purpose and scope of the inspection are to provide you with a better understanding of the general condition of the pre-drywall interior of the structure. This includes ceilings, walls, floors, windows, electrical and plumbing, and the general condition of the structure's exterior. We did not inspect using a tape measure to determine where walls, floors, or stairs are to be located.

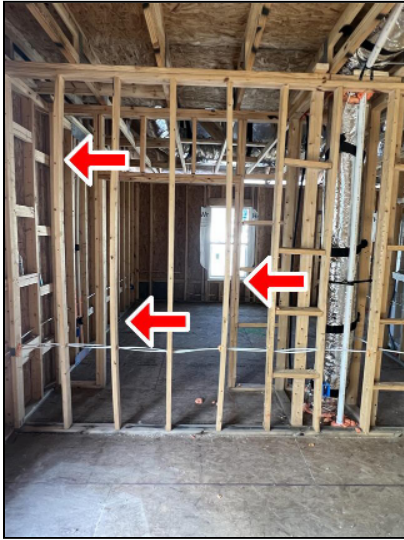
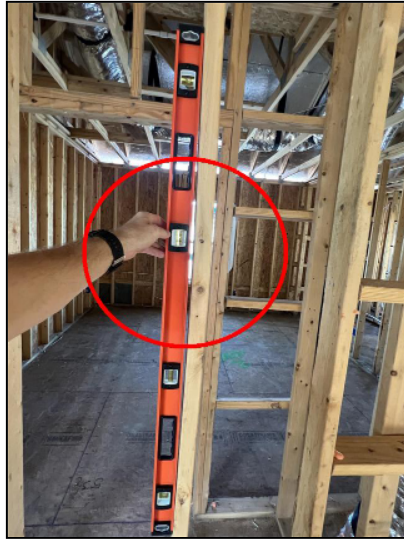
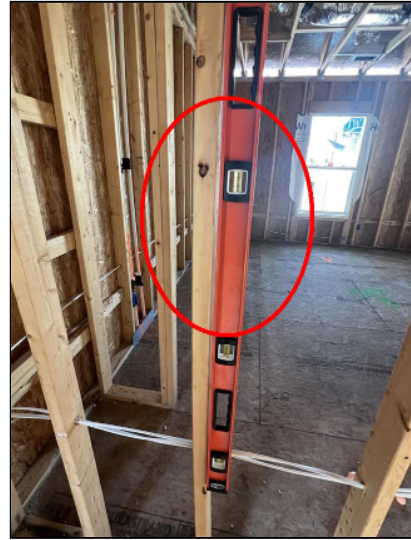
2.1 (1) The wall separating the bedroom closet and the bonus room has three wrapped 2x4s. I recommend talking to the builder to see if additional support is needed for the 2x4s or replace if them needed.

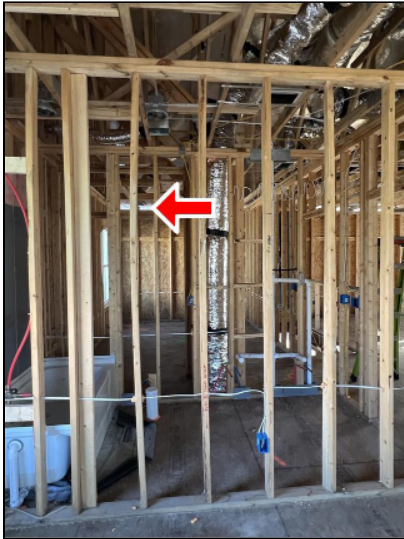
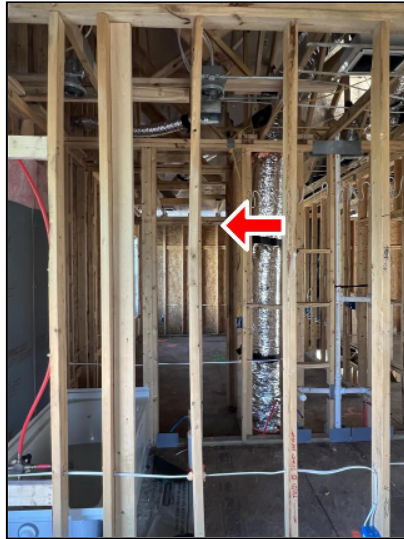
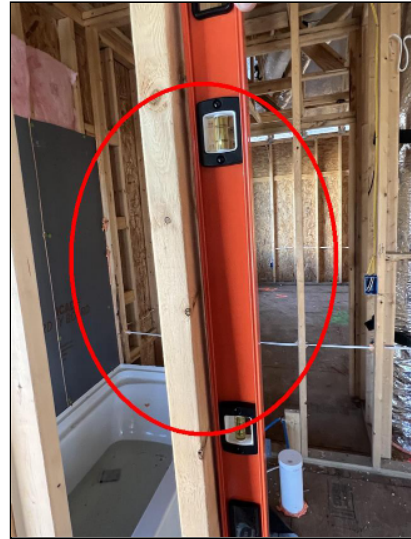
2.1 (2) The wall separating the bedroom and guest bathroom has a wrapped 2x4s. I recommend talking to the builder to see if additional support is needed for the 2x4s or replace them if needed.

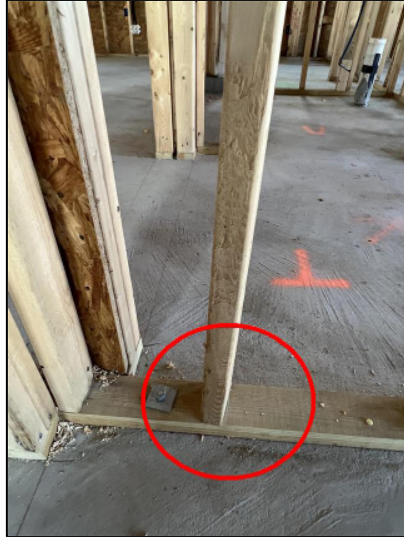
2.1 (3) One of the 2x4s in the master bedroom is wrapped and twisted. I recommend talking to the builder to see if additional support is needed for the 2x4s or replace them if needed.

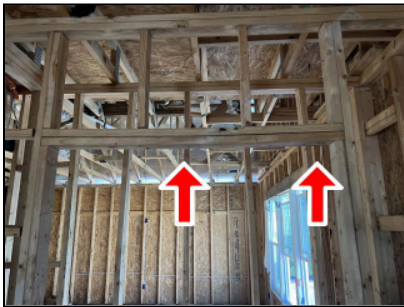
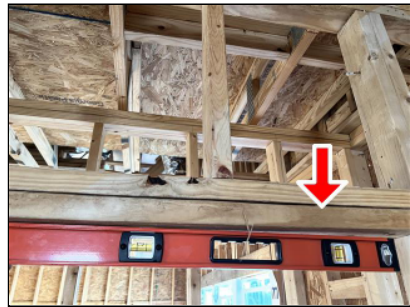
2.1 (4) The header for the second bedroom closet is not square and could affect the doors when installed. I recommend repair by a qualified professional.

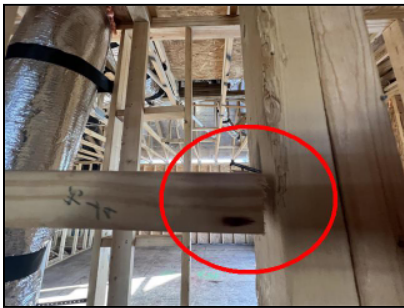
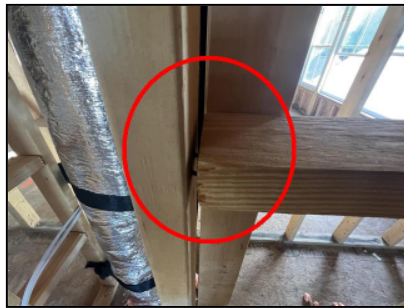
2.1 (5) The blocking in the second-floor closet is not installed correctly and will not provide any support. I recommend repair by a qualified professional.

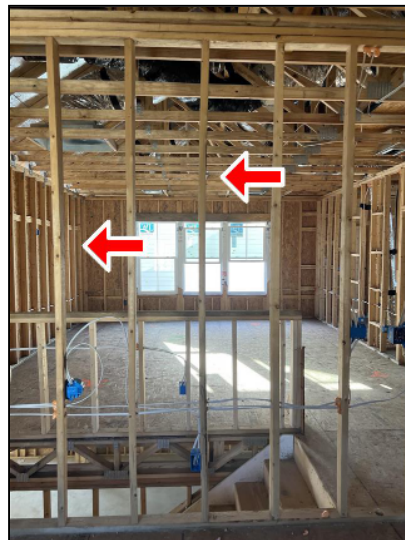
2.1 Item 17(Picture)

2.1 (6) There are wrapped 2x4s along the stairwell wall in the third bedroom. I recommend talking to the builder to see if additional support is needed for the 2x4s or replace them if needed.

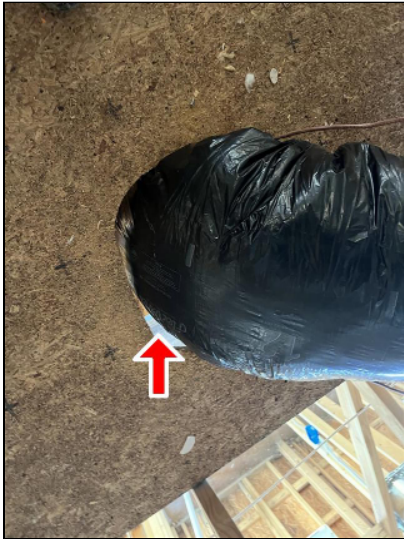
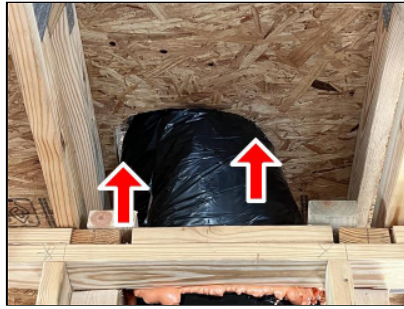
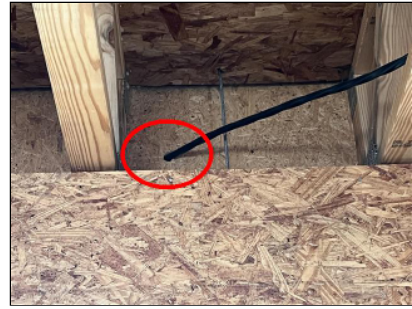
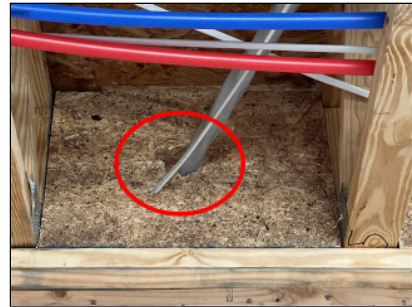
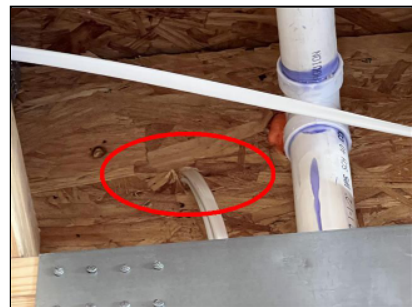
2.4 Several areas on the main floor (middle beam) are missing fire-blocking foam. I recommend having all these areas where water pipes and electrical run through the main beam on the first floor and the second floor HVAC be fire-blocked.

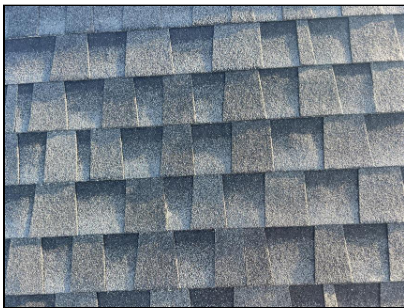
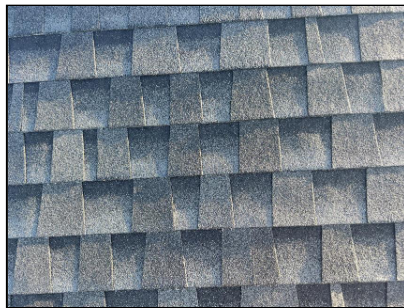
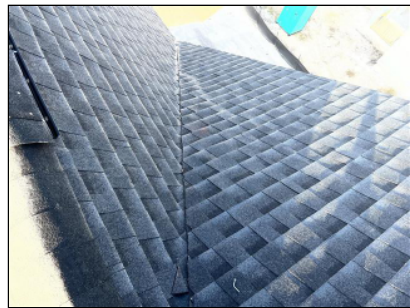
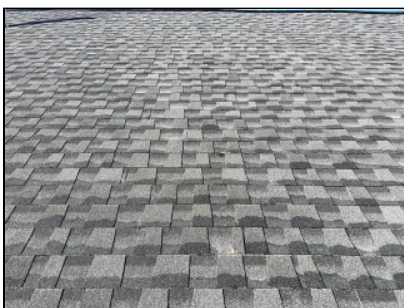
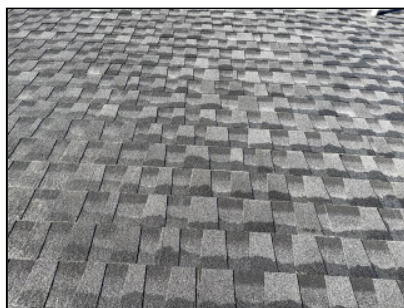
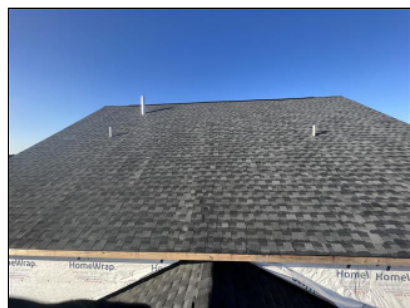
3.0 I walked the roof, and the shingles are in good shape. No apparent problems were observed. Additionally, the front porch has yet to be shingled.

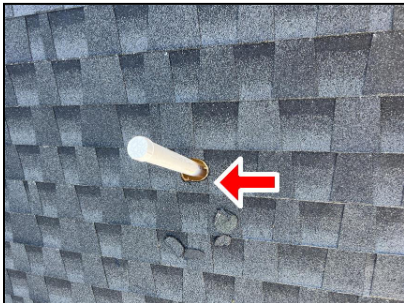
3.2 Item 1(Picture)

3.2 (1) The vent boots have yet to be installed, and the nails still need to be sealed. This will be addressed at the final inspection to ensure they have been completed.

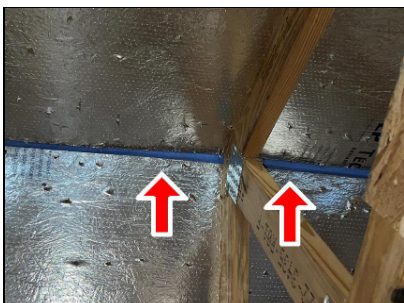
3.2 Item 6(Picture)

3.2 (2) The roofing material has not been cut out of the ridged vent. The ridge vent allows fresh air to circulate through the attic. Additionally, there should be a 1.5" to 2.5" of open space (no plywood) on either side of the ridge board for attic air to escape through the ridge vent. I recommend further evaluation by a qualified professional and correct as needed.

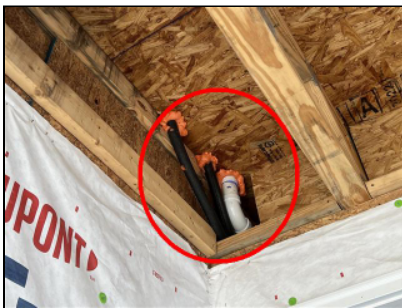
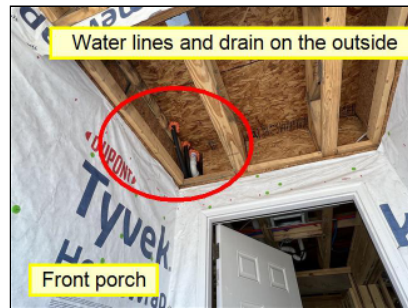
5.0 The drain from the second-floor bathroom appears to go outside of the house, along with the water lines. There is a chance the drain or water lines could freeze. The water lines were insulated; however, the drain was not. I recommend further evaluation by a qualified professional and correct as needed.

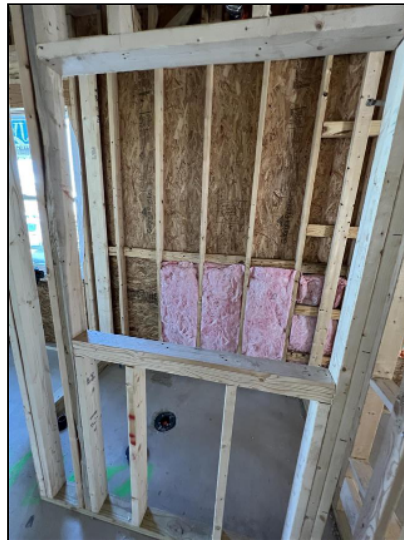
5.1 Item 1(Picture)

5.1 The master bedroom shower area was not completed at the time of the inspection.

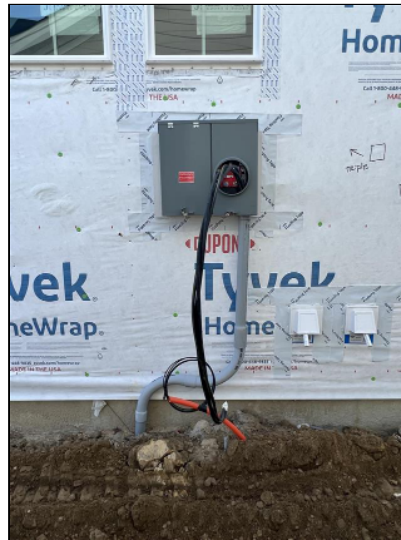
6.0 Item 1(Picture)

6.0 The service entrance and main breaker are located at the side of the house.

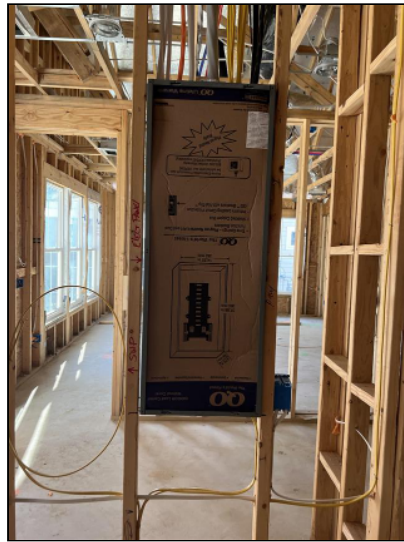
6.1 Item 1(Picture)

6.1 The main distribution panel is located in the laundry room.

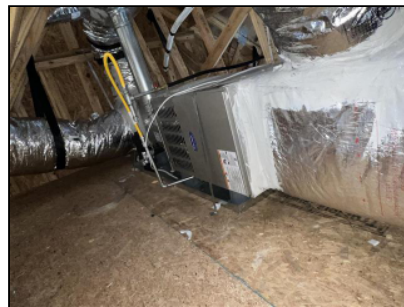
7.0 Item 1(Picture)

7.0 I made a visual inspection of the heating unit and air-handler. A full inspection is not conducted until the system has power. The heating and air-handler unit was manufactured in 2022 and is located in the attic. The electric service disconnect is located near the unit.

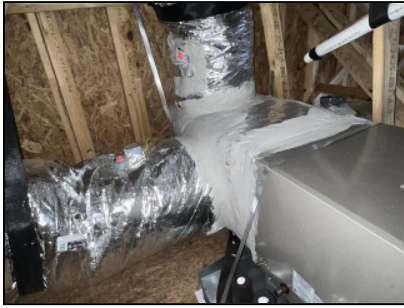
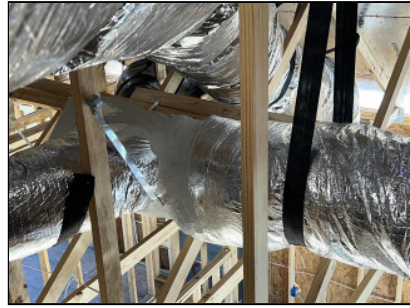
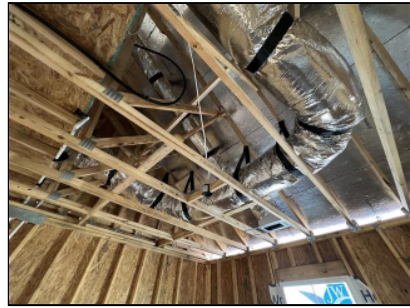
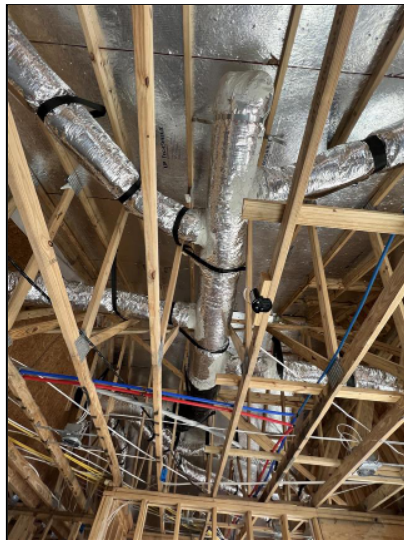
7.1 A visual inspection of the ductwork was completed. No apparent problems were observed.

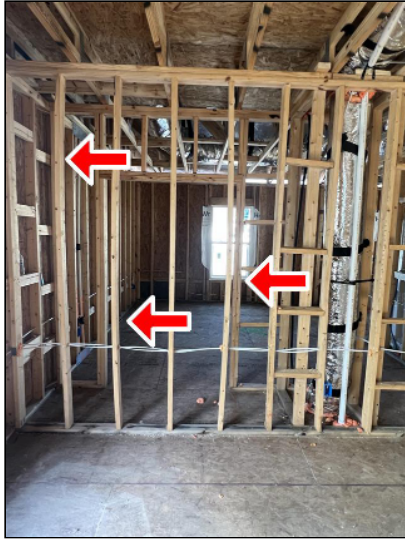
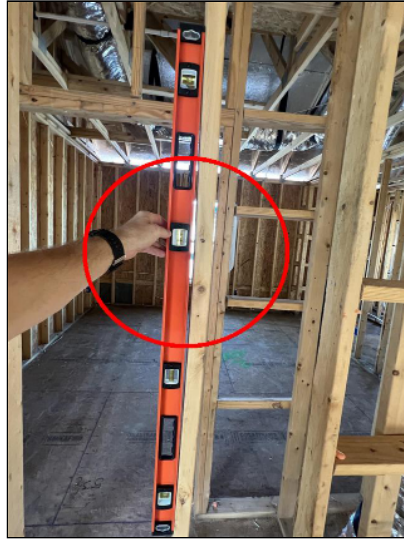
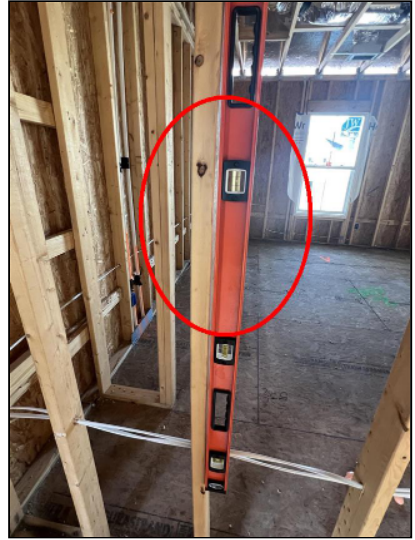
(1) The wall separating the bedroom closet and the bonus room has three wrapped 2x4s. I recommend talking to the builder to see if additional support is needed for the 2x4s or replace if them needed.

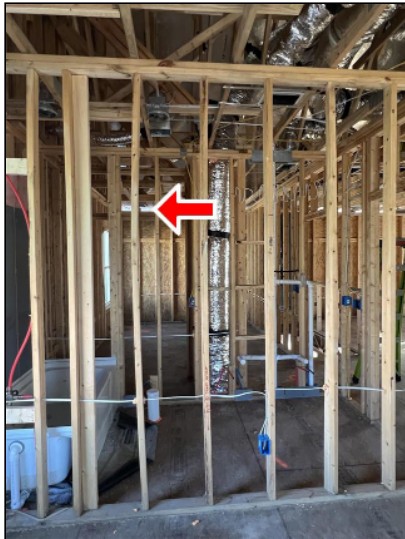
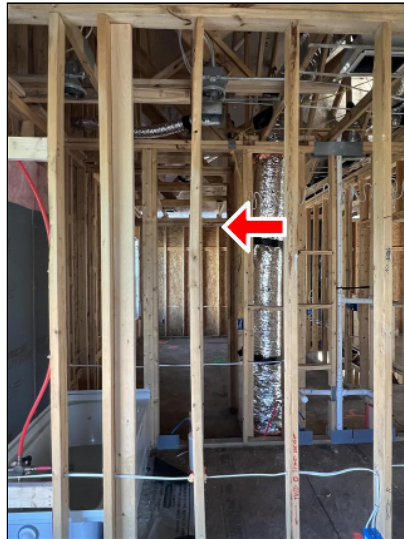
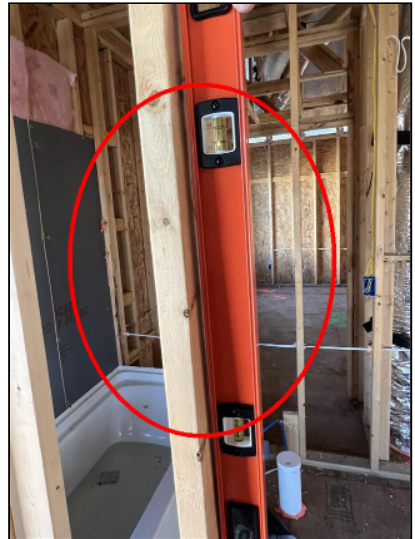
(2) The wall separating the bedroom and guest bathroom has a wrapped 2x4s. I recommend talking to the builder to see if additional support is needed for the 2x4s or replace them if needed.

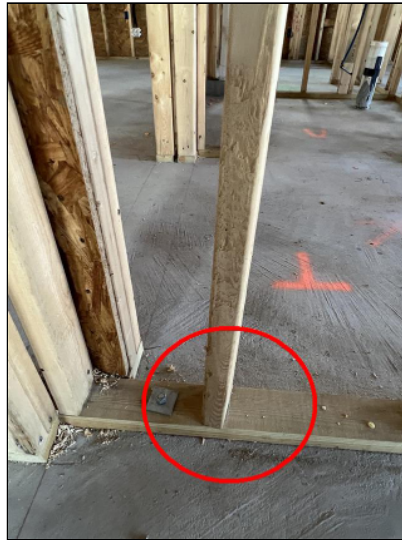
(3) One of the 2x4s in the master bedroom is wrapped and twisted. I recommend talking to the builder to see if additional support is needed for the 2x4s or replace them if needed.

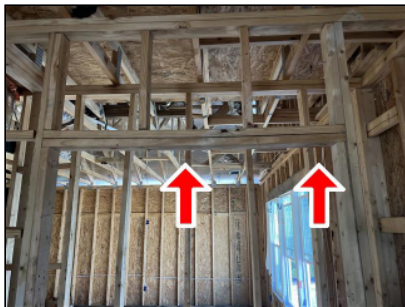
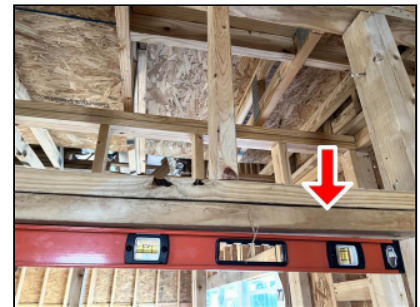
(4) The header for the second bedroom closet is not square and could affect the doors when installed. I recommend repair by a qualified professional.

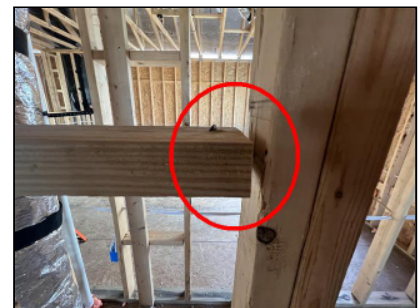
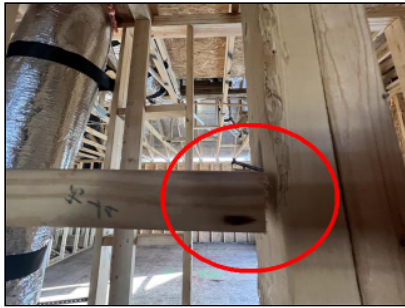
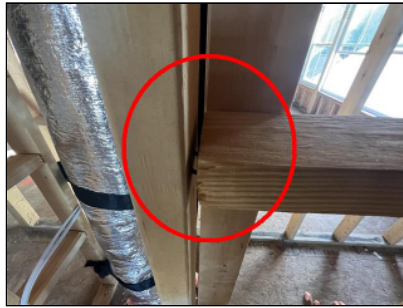
(5) The blocking in the second-floor closet is not installed correctly and will not provide any support. I recommend repair by a qualified professional.

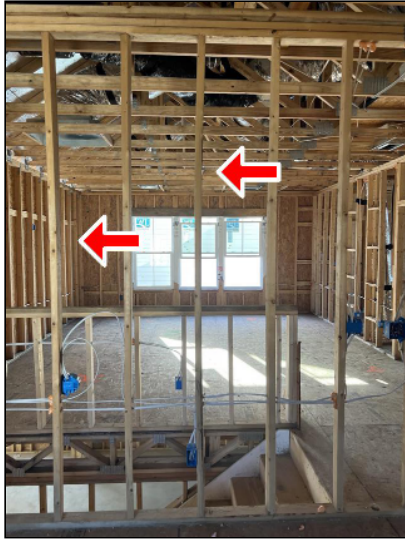
2.1 Item 17(Picture)

(6) There are wrapped 2x4s along the stairwell wall in the third bedroom. I recommend talking to the builder to see if additional support is needed for the 2x4s or replace them if needed.

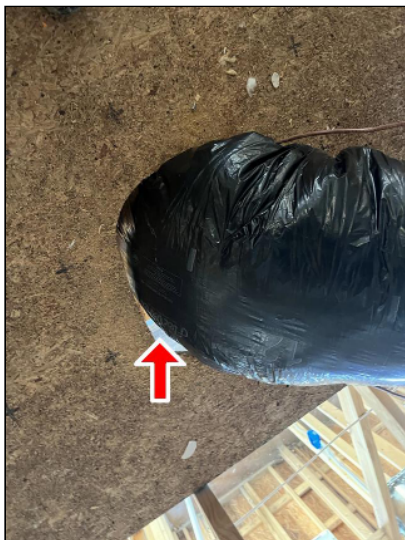
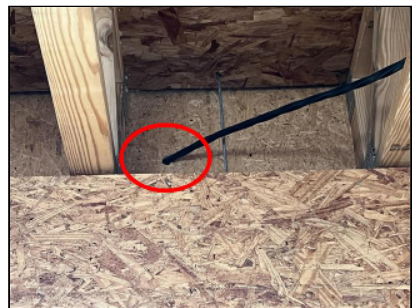
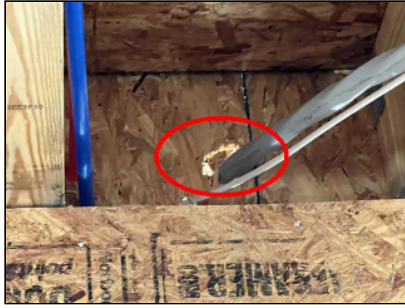
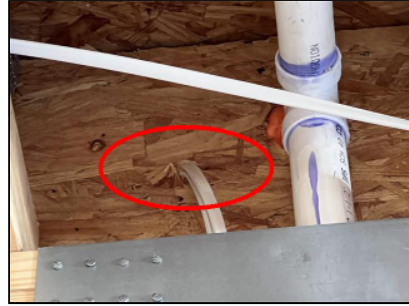
Several areas on the main floor (middle beam) are missing fire-blocking foam. I recommend having all these areas where water pipes and electrical run through the main beam on the first floor and the second floor HVAC be fire-blocked.

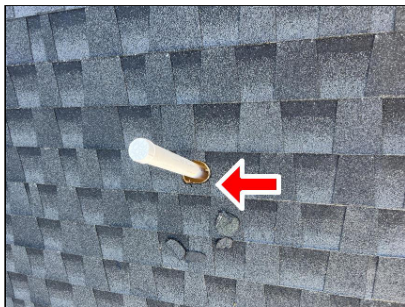
3.2 Item 1(Picture)

(1) The vent boots have yet to be installed, and the nails still need to be sealed. This will be addressed at the final inspection to ensure they have been completed.

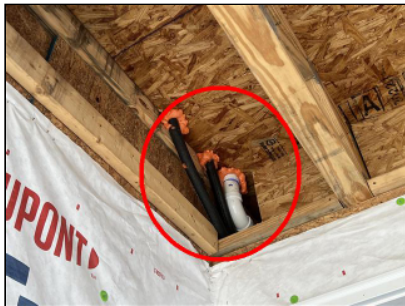
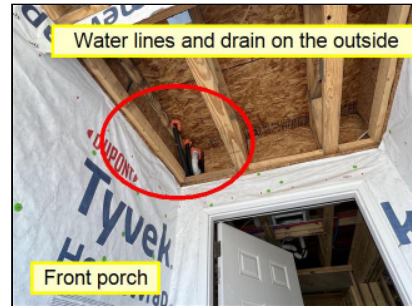
The drain from the second-floor bathroom appears to go outside of the house, along with the water lines. There is a chance the drain or water lines could freeze. The water lines were insulated; however, the drain was not. I recommend further evaluation by a qualified professional and correct as needed.
