# Inspection Report

1234 Main st  
Johns Island SC

**DP Inspections**

<b>Date:</b> 9/17/2018	<b>Time:</b> 01:30 PM	<b>Report ID:</b> 1
<b>Property:</b> 1234 Main St.	<b>Customer:</b> Mr. and Mrs. Smith	<b>Real Estate Professional:</b>

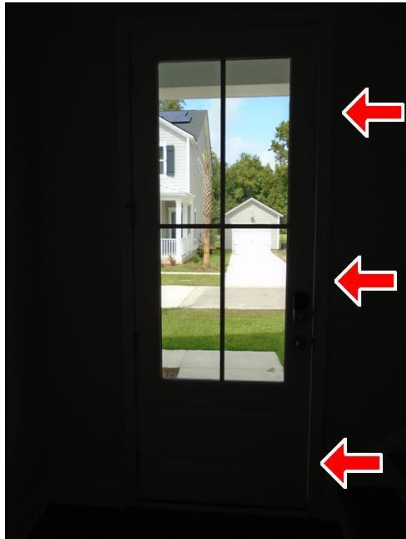
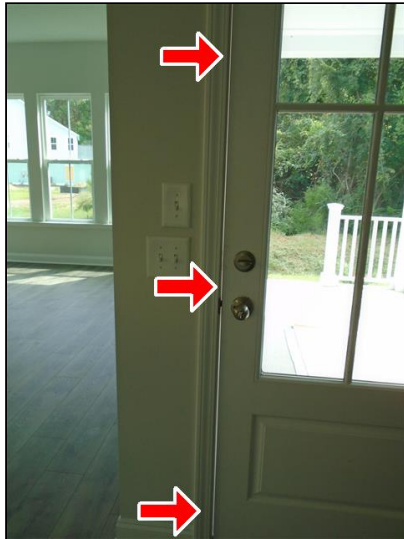
**2.1 (1)** The front door and back door are missing the weather stripping around the door frame. This can lead to the loss of air conditioning or heat if not repaired. I recommend repair by a qualified professional.

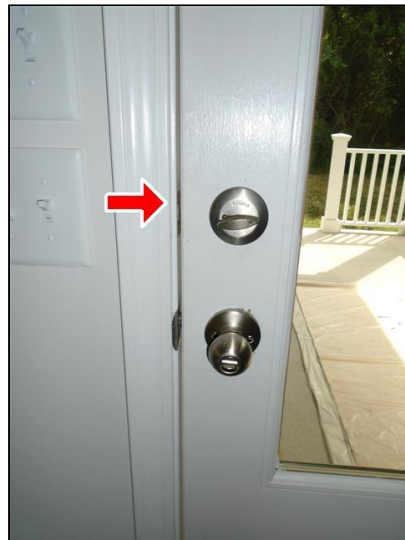
2.1 Item 3(Picture)

**2.1 (2)** The dead bolt is not aligned with the striker plate and will not lock. I recommend repair by a qualified professional.

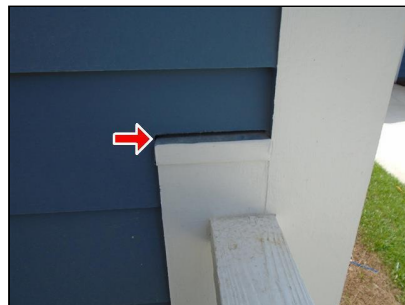
2.3 Item 1(Picture)

**2.3** This area (right side of the front porch when facing the house) is not caulked and could allow water intrusion behind the cladding. I recommend repair.

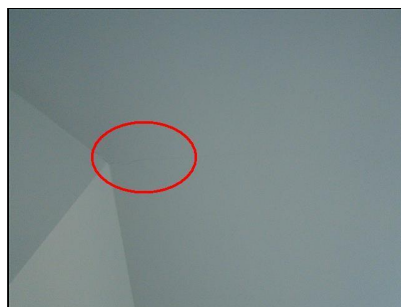
4.0 Item 1(Picture)

**4.0** There is a small ceiling crack at the top of the stairs. This is most likely caused by the house settling. This is considered cosmetic and repair as needed.

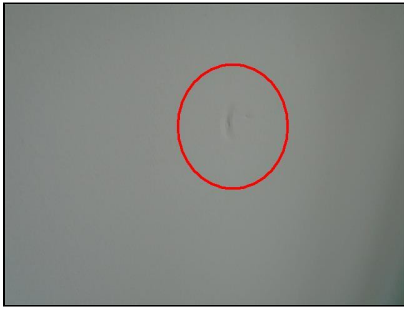
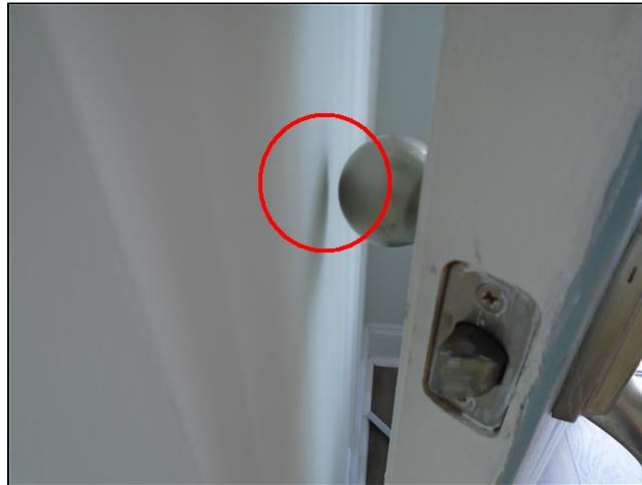
**4.1** (1) The dry wall behind the front door is damaged. This was most likely caused by the door handle (Item 2). I recommend installing a door stopper to prevent the door from hitting the wall and repair as needed.

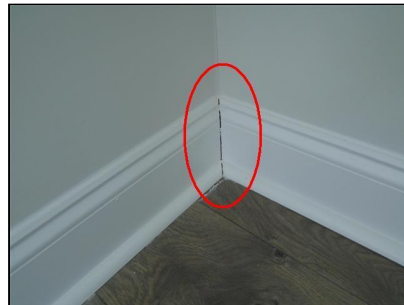
4.1 Item 3(Picture)

**4.1** (2) This is one representation of the baseboard corners throughout the house. Many of the baseboard corners have not been caulked. These cracks are cosmetic and recommend repair as needed.

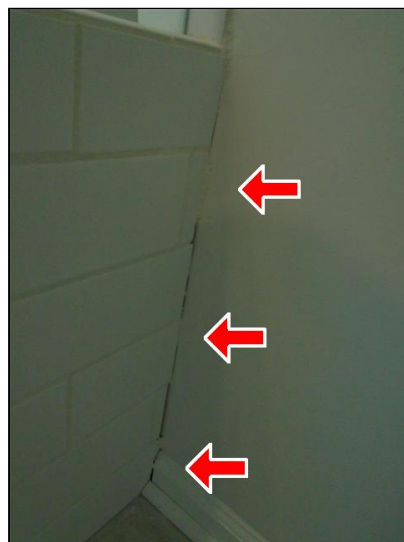
4.1 Item 4(Picture)

**4.1** (3) The caulking is missing between the wall and the shower tile in the master bathroom. This is considered cosmetic and recommend repair as needed.

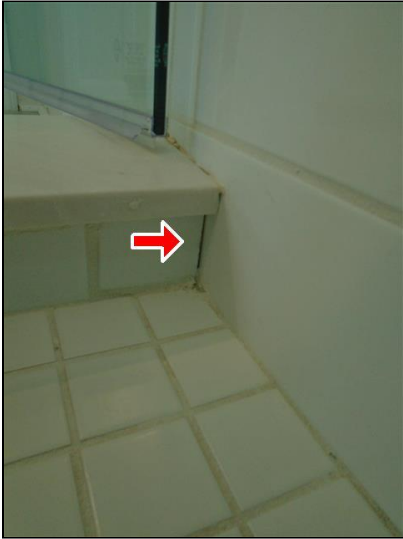
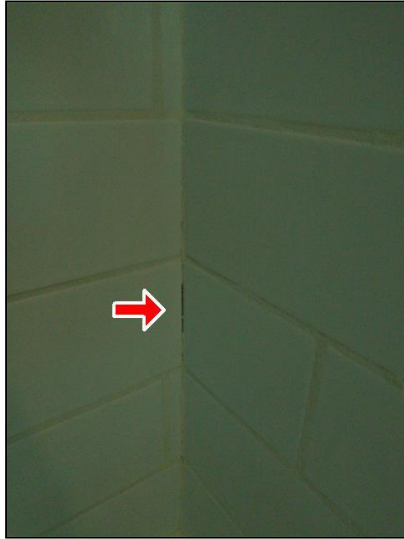
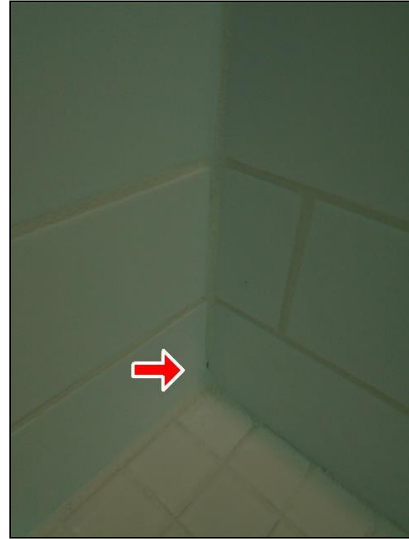
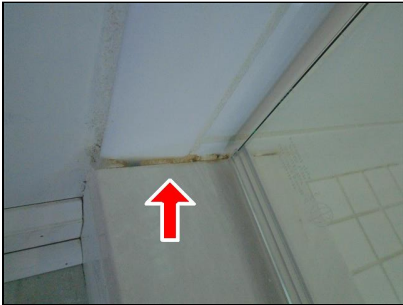
**4.1** (4) The master bedroom shower has several areas that the caulking is missing or deteriorated. This can lead to water intrusion behind the shower walls. I recommend repair by a qualified professional.

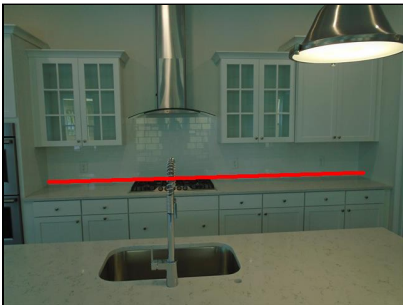
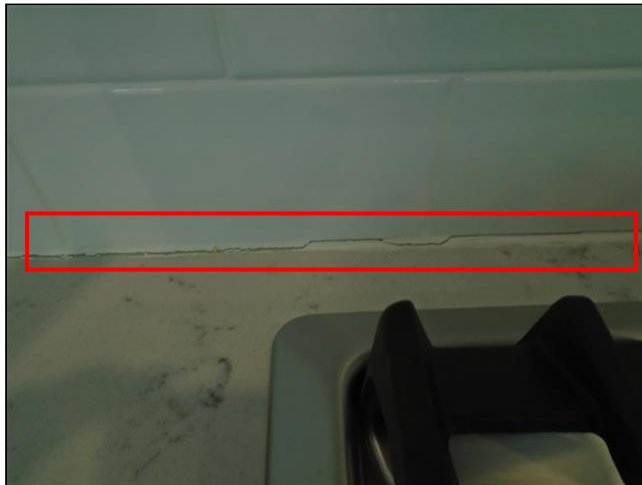
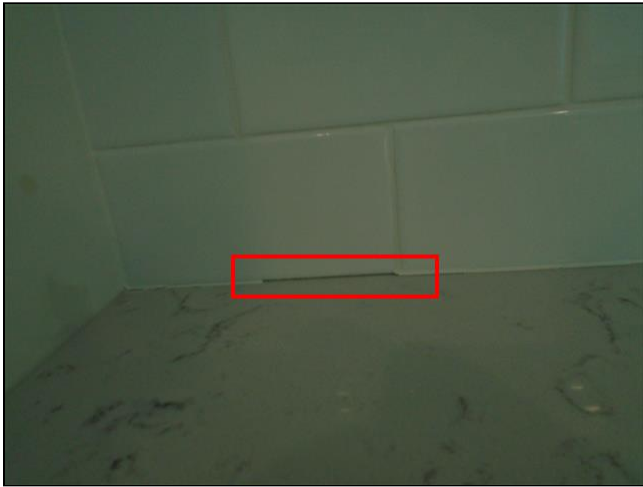
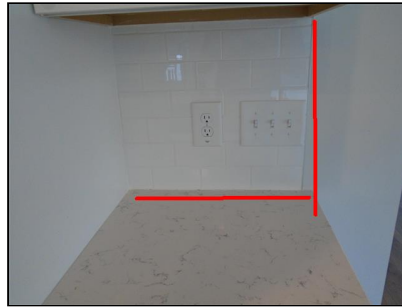
**4.1** (5) The caulking in the kitchen area is cracked or missing in these areas. I recommend repair by a qualified professional.

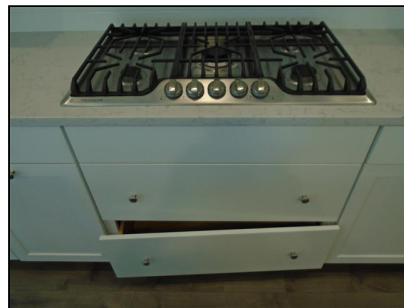
4.4 Item 1(Picture)

**4.4** (2) The bottom drawer under the stove top is not installed correctly and will not open or close. I recommend repair by a qualified professional.

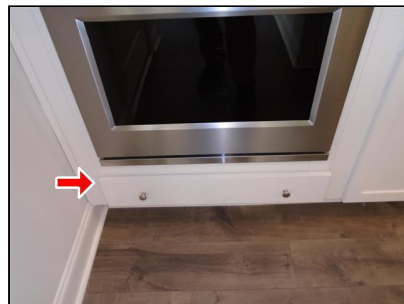
4.4 Item 2(Picture)

**4.4** (3) The cabinet drawer under the double oven does not work smoothly. Recommend repair or replace as necessary.

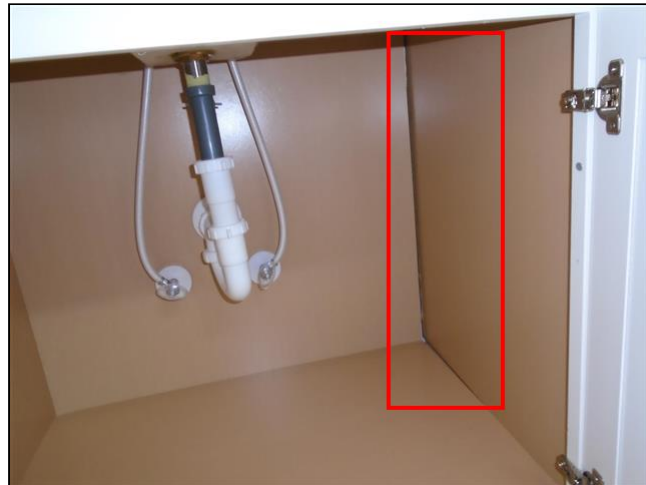
4.4 Item 3(Picture)

**4.4** (4) The cabinet under the master bath sink is broken and separated. This could allow water penetration behind the sink wall. I recommend repair by a qualified professional.

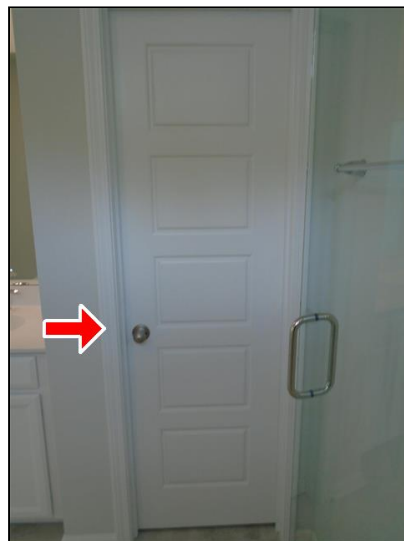
4.5 Item 1(Picture)

**4.5** (1) The door latch in the master bathroom (water closet) does not align with the striker plate. The door will not remain shut unless corrected. I recommend repair by a qualified professional.

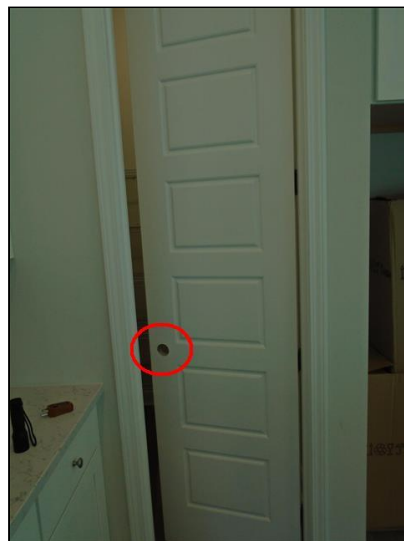
4.5 Item 2(Picture)

**4.5** (2) The kitchen pantry door is missing the hardware. I recommend repair by a qualified professional.

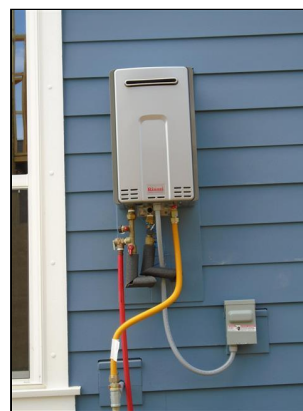
6.2 Item 1(Picture)

**6.2** The tankless hot water is located on the left side of the house (front facing). For you information tankless water heaters heat water directly without the use of a storage tank. When a hot water tap is turned on, cold water travels through a pipe into the unit. As a result, tankless water heaters deliver a constant supply of hot water.

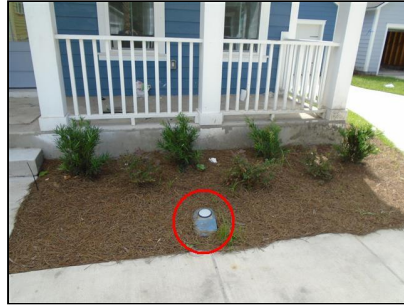
6.3 Item 1(Picture)

**6.3** The main shut off is located outside in the ground in front of the house.

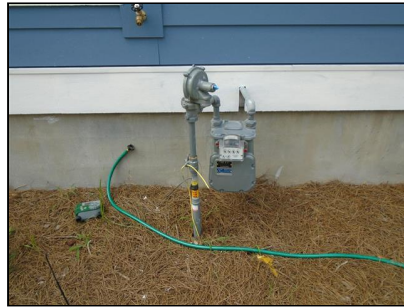
6.4 Item 1(Picture)

**6.4** Gas shut off is located on the left side of the house (front facing)

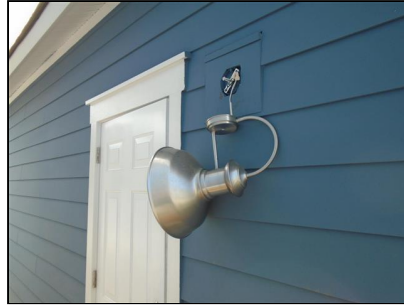
7.3 Item 1(Picture)

**7.3** (1) The outside light on the garage is not attached to the wall cladding and is being held up by the wires. I recommend repair by a qualified professional.

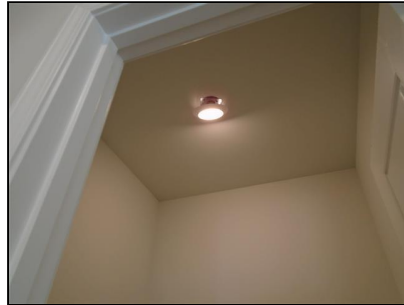
7.3 Item 2(Picture)

**7.3** (2) The light in the kitchen panty is not secured to the ceiling. I recommend repair by a qualified professional.

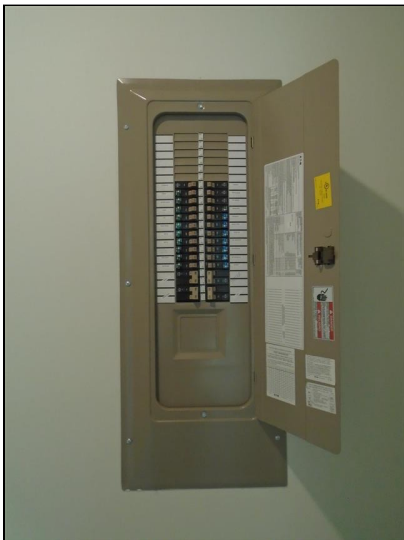
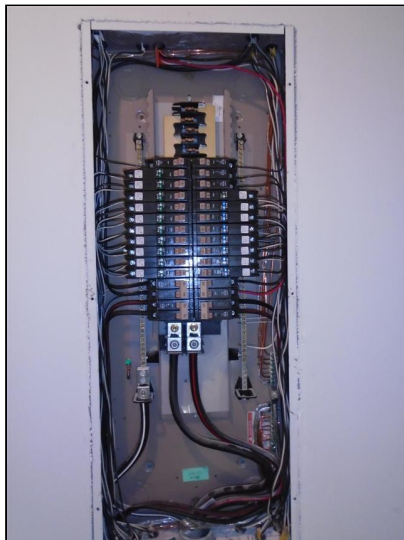
**7.7** (1) The main distribution panel is located in the laundry room on the second floor. There is no main power shut off located in the panel. I recommend asking the builder where the main power shut off is located prior to moving in.

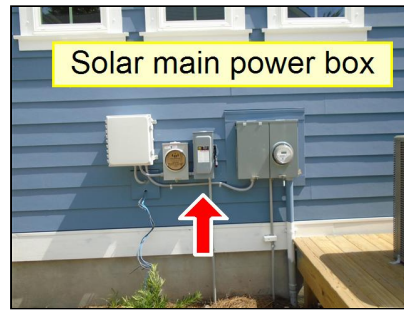
7.7 Item 3(Picture)

**7.7** (2) The home is also equipped with solar energy and does not appear to be hooked up at this time. I would recommend having the system tested prior moving in.

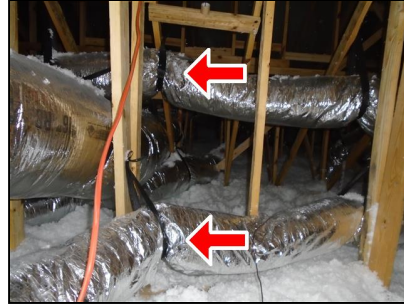
8.3 Item 1(Picture)

**8.3** The support straps seem to be tight around the duct work and may be restricting the flow of air through the ducts which could lead to higher heating and cooling costs. I recommend repair by a qualified professional.

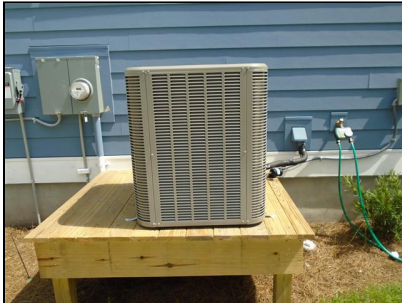
8.7 Item 1(Picture)

**8.7** (1) The HAVC system was manufactured in 2018. Most organizations and companies can agree that homeowners can see between 15-25 years in their system's lifetime. As long as you maintain the system well and have regular tune-ups/servicing, you'll find your system lasts a very long time. Many homeowners decide to replace it after about 10-15 years for a new.

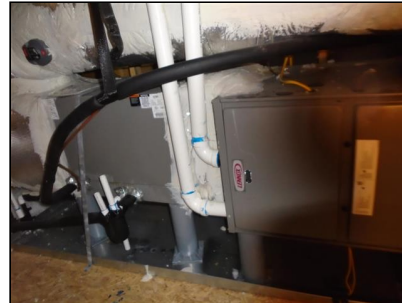
8.7 Item 3(Picture)

**8.7** (2) The ambient air test was performed by using thermometers on the air handler of Heat pump in cool mode to determine if the difference in temperatures of the supply and return air are between 14 degrees and 22 degrees which indicates that the unit is cooling as intended. The supply air temperature on your system read 56 degrees, and the return air temperature was 72 degrees. This indicates the range in temperature drop is normal.

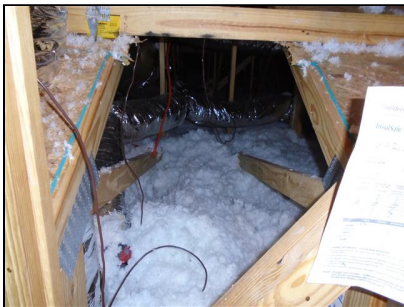
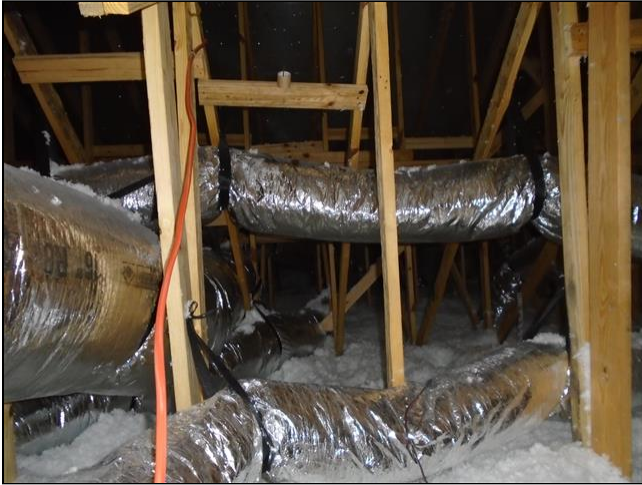
**9.0 (1)** There is insulation distributed through the attic and look to be sufficiently deep. The images provided are for your information.

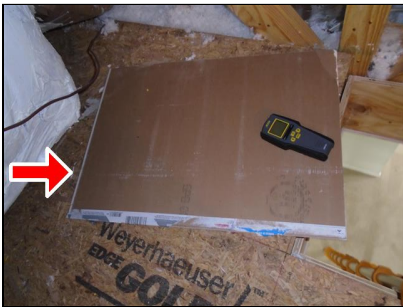
9.0 Item 4(Picture)

**9.0 (2)** Item 4(Picture) is the current attic access panel that is being used and it is not insulated. The attic access hole insulation needs to fill the entire space and be in significant contact with all four sides of the wood 'dam' that is built inside the attic for the access panel to slide up through. When the insulation piece is too small, it doesn't touch all four sides and allows for heat loss. Item 5(Picture) appears to be the proper attic access panel that is sitting (located) in the attic. I recommend that the proper attic access panel be in place prior to moving into the home.

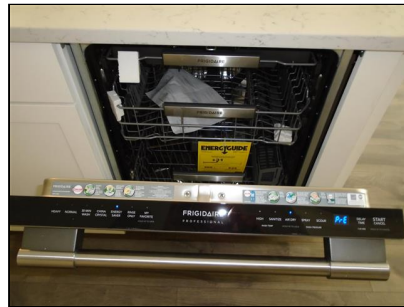
10.0 Item 1(Picture)

**10.0** The dishwasher was not inspected as it still contained the packaging material. I recommend testing the dishwasher prior to moving into the home.

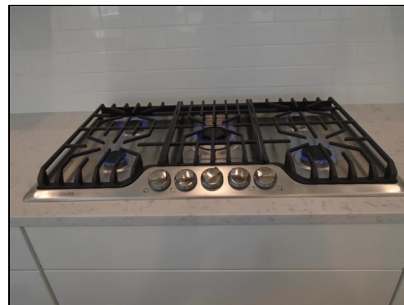
10.1 Item 1(Picture)

**10.1** All stove top burners were functional when I operated the controls.

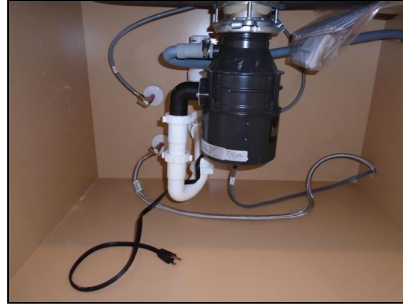
10.3 Item 1(Picture)

**10.3** The food waste disposer was not hooked up at the time of inspection. I recommend testing the disposal prior to moving into the home.

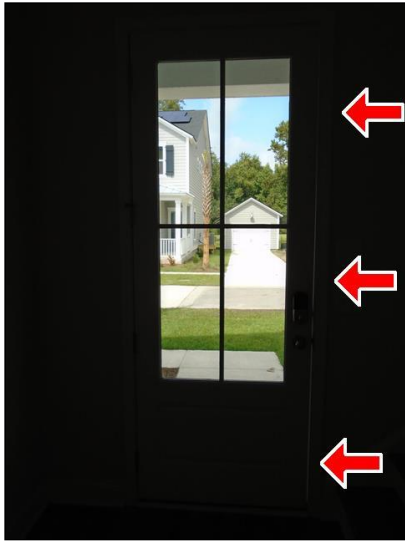
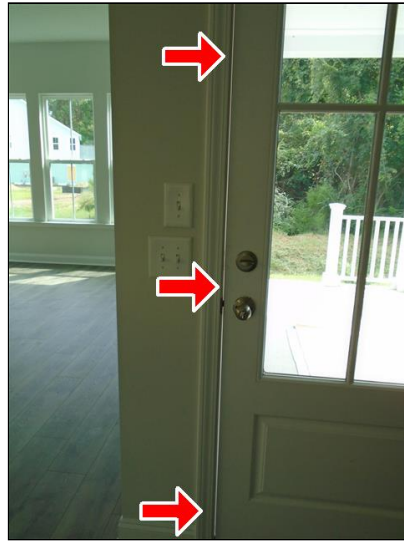
(1) The front door and back door are missing the weather stripping around the door frame. This can lead to the loss of air conditioning or heat if not repaired. I recommend repair by a qualified professional.

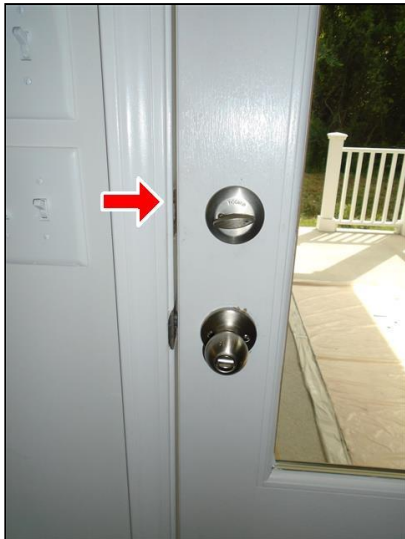
2.1 Item 3(Picture)

(2) The dead bolt is not aligned with the striker plate and will not lock. I recommend repair by a qualified professional.

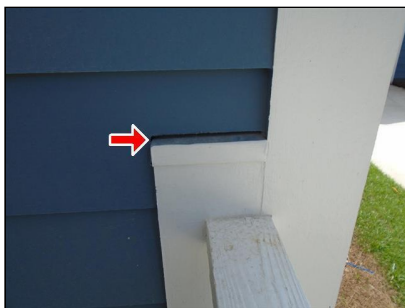
2.3 Item 1(Picture)

This area (right side of the front porch when facing the house) is not caulked and could allow water intrusion behind the cladding. I recommend repair.

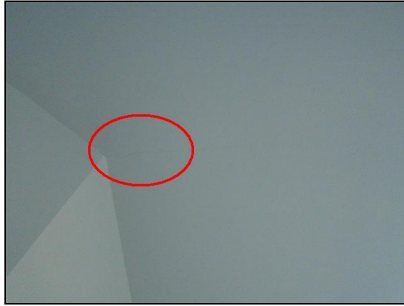
4.0 Item 1(Picture)

There is a small ceiling crack at the top of the stairs. This is most likely caused by the house settling. This is considered cosmetic and repair as needed.

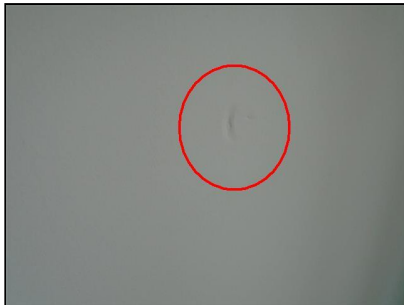
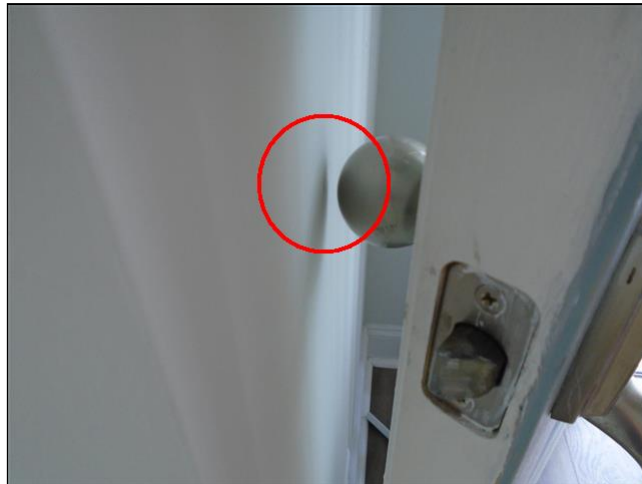
(1) The dry wall behind the front door is damaged. This was most likely caused by the door handle (Item 2). I recommend installing a door stopper to prevent the door from hitting the wall and repair as needed.

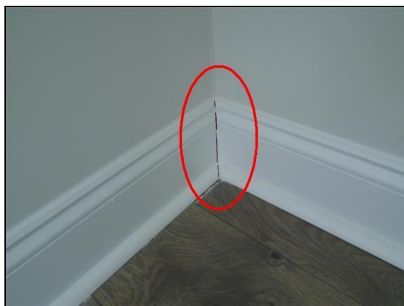
4.1 Item 3(Picture)

(2) This is one representation of the baseboard corners throughout the house. Many of the baseboard corners have not been caulked. These cracks are cosmetic and recommend repair as needed.

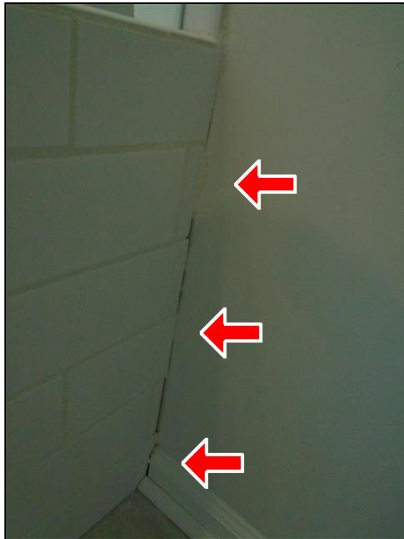
4.1 Item 4(Picture)

(3) The caulking is missing between the wall and the shower tile in the master bathroom. This is considered cosmetic and recommend repair as needed.

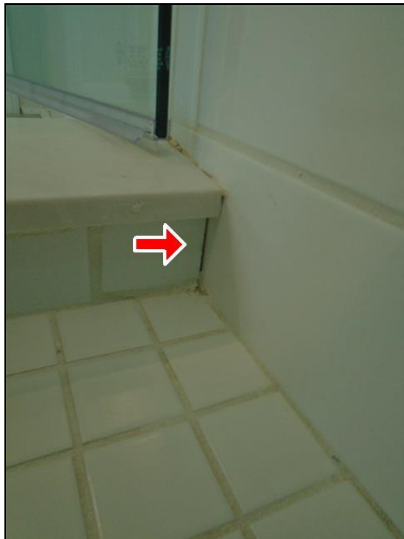
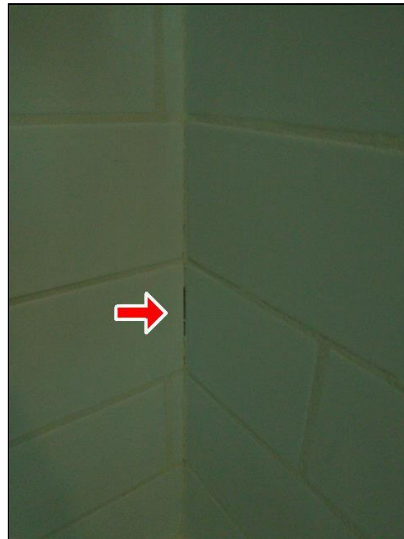
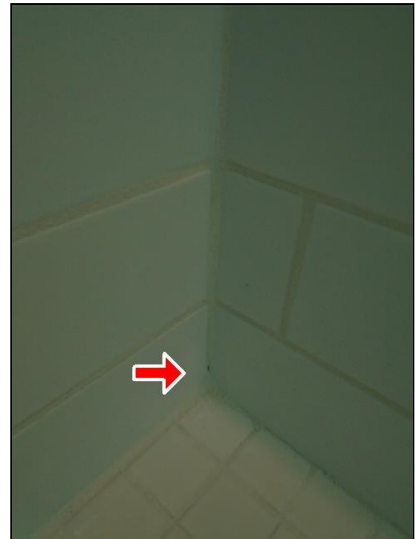
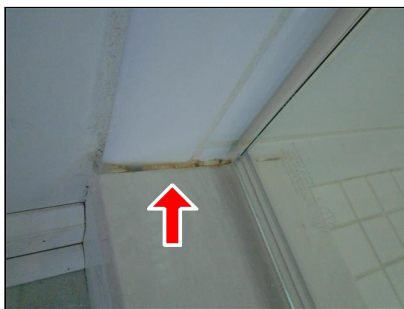
(4) The master bedroom shower has several areas that the caulking is missing or deteriorated. This can lead to water intrusion behind the shower walls. I recommend repair by a qualified professional.

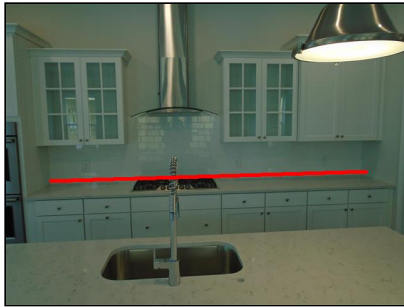
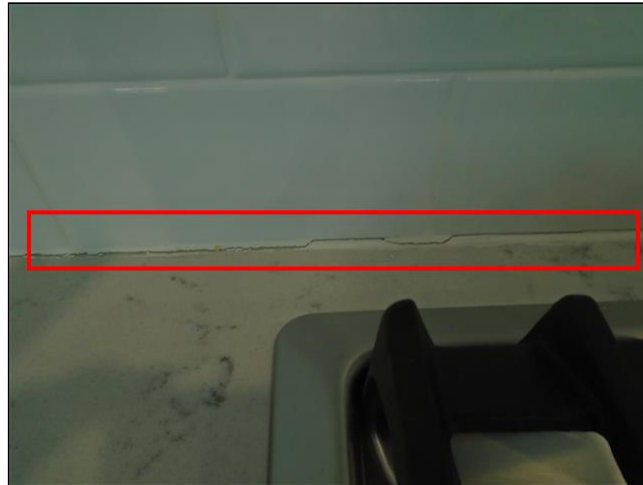
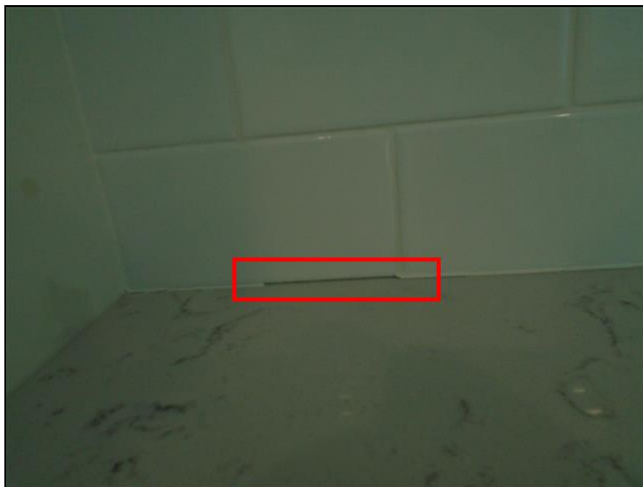
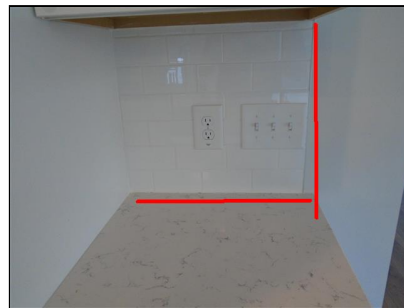
(5) The caulking in the kitchen area is cracked or missing in these areas. I recommend repair by a qualified professional.

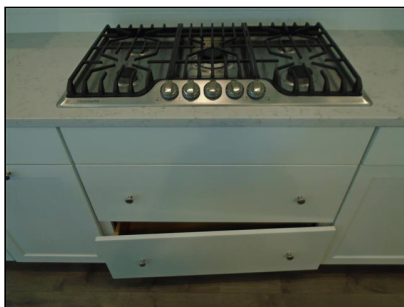
4.4 Item 1(Picture)

(2) The bottom drawer under the stove top is not installed correctly and will not open or close. I recommend repair by a qualified professional.

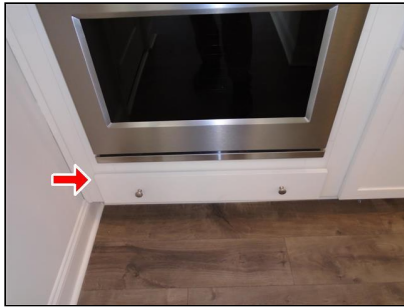
4.4 Item 2(Picture)

(3) The cabinet drawer under the double oven does not work smoothly. Recommend repair or replace as necessary.

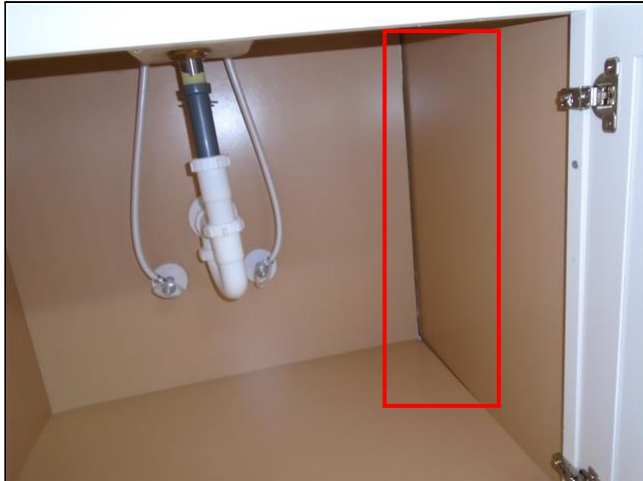
4.4 Item 3(Picture)

(4) The cabinet under the master bath sink is broken and separated. This could allow water penetration behind the sink wall. I recommend repair by a qualified professional.

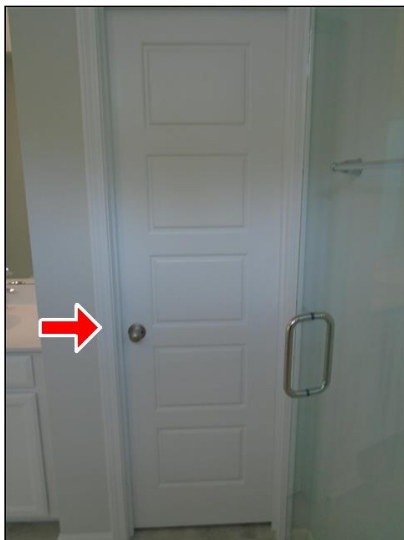
4.5 Item 1(Picture)

(1) The door latch in the master bathroom (water closet) does not align with the striker plate. The door will not remain shut unless corrected. I recommend repair by a qualified professional.

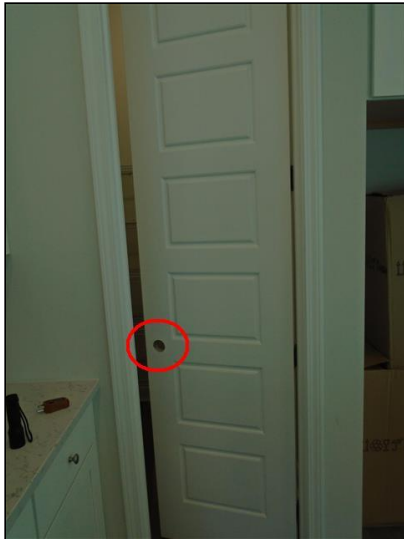
4.5 Item 2(Picture)

(2) The kitchen pantry door is missing the hardware. I recommend repair by a qualified professional.

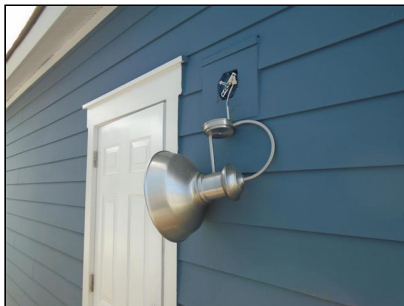
7.3 Item 1(Picture)

(1) The outside light on the garage is not attached to the wall cladding and is being held up by the wires. I recommend repair by a qualified professional.

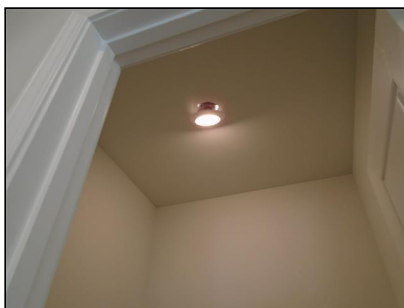
7.3 Item 2(Picture)

(2) The light in the kitchen pantry is not secured to the ceiling. I recommend repair by a qualified professional.

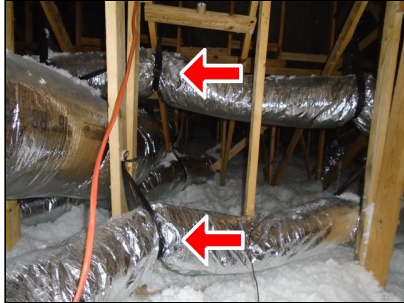
8.3 Item 1(Picture)

The support straps seem to be tight around the duct work and may be restricting the flow of air through the ducts which could lead to higher heating and cooling costs. I recommend repair by a qualified professional.
