# Inspection Report

**DP Inspections LLC**

<b>Date:</b> 2/15/2023	<b>Time:</b> 08:30 AM	<b>Report ID:</b> 1 [REDACTED]
<b>Property:</b> [REDACTED] Mount Pleasant SC 29466	[REDACTED]	<b>Real Estate Professional:</b> [REDACTED]

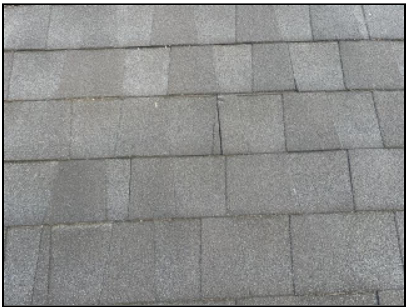
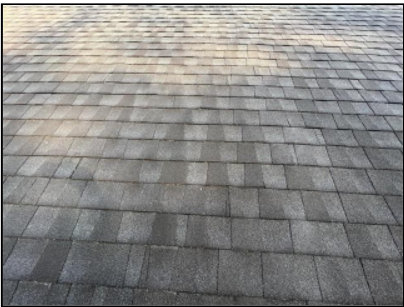
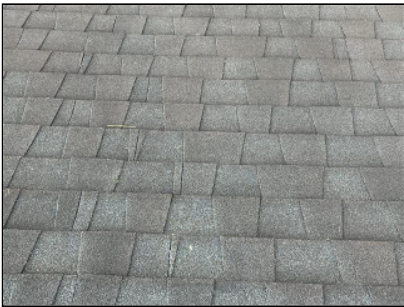
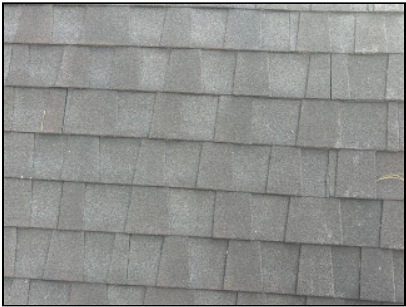
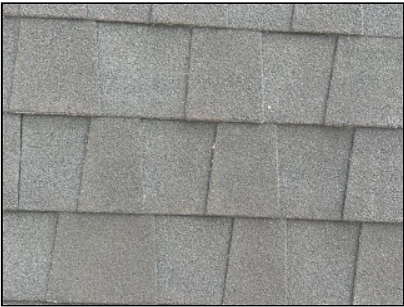
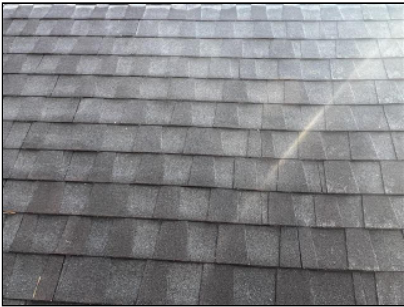
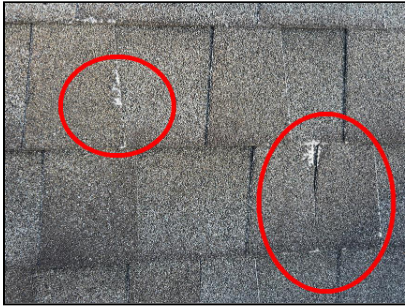
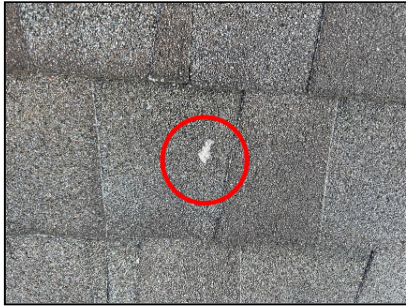
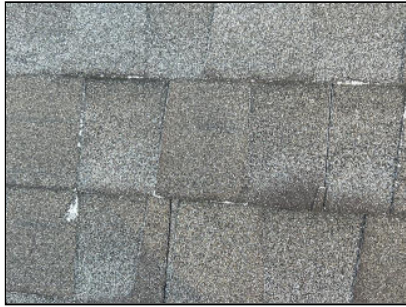
**1.0** I walked the roof, and overall the shingles are in good shape. One section of the roof is starting to show signs of granular loss. With the age of the roof, that is common. No obvious problems were discovered. Pictures are for your reference.

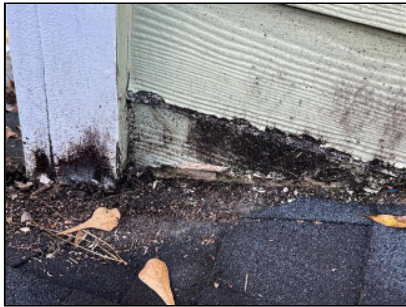
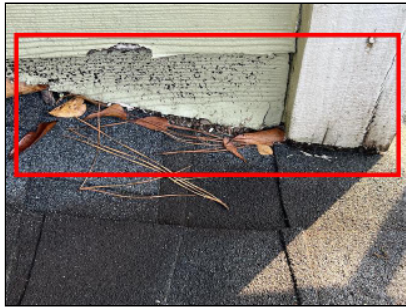
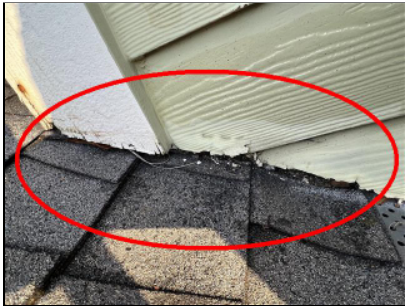
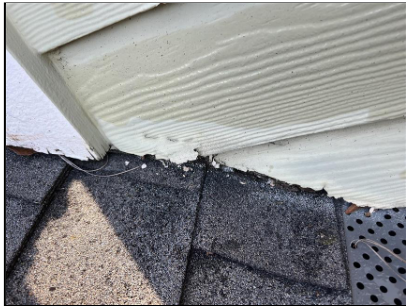
**1.1** The base of the chimney, around the cricket flashing, has severe moisture damage. In addition, there is wood rot on the trim, and the siding has moisture damage. It appears this area holds water, and the cricket flashing may need to be larger, or another flashing may need to be installed. I recommend further evaluation by a qualified professional and correct it as needed.

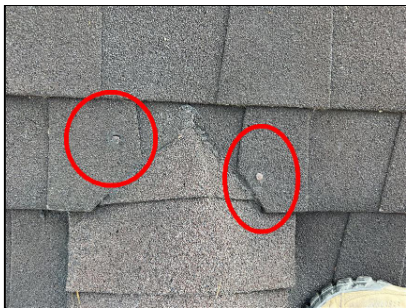
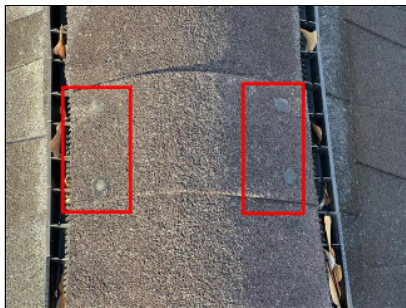
**1.2** The nail heads on the ridge caps are exposed. Exposed nail heads can increase the chance of water penetration into the house. I recommend having the nail heads sealed with a roof sealant.

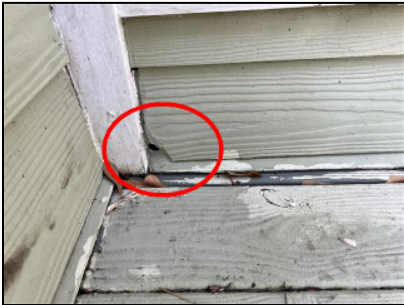
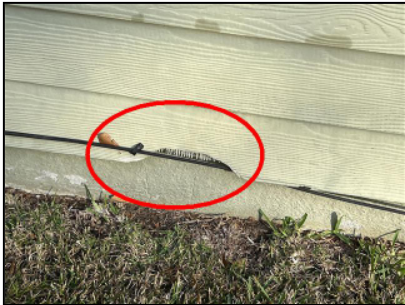
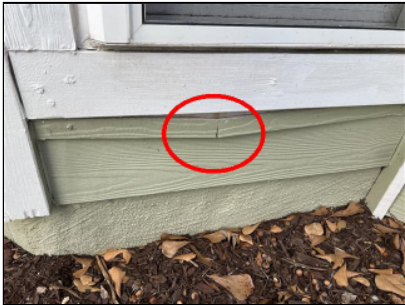
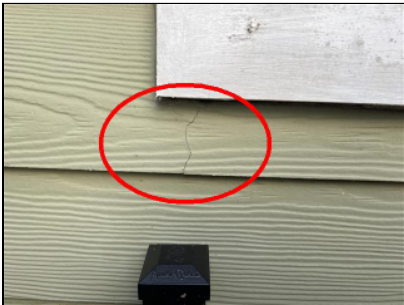
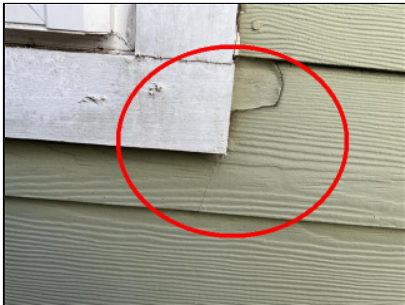
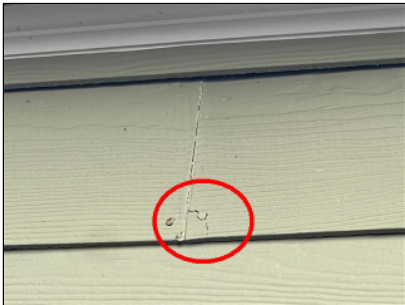
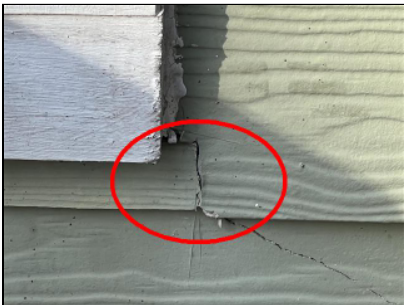
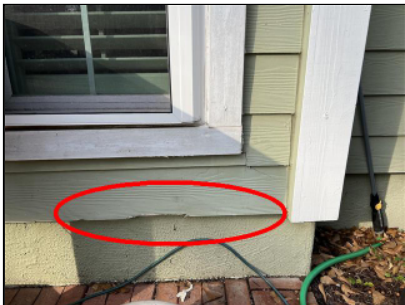
**2.0 (3)** Several pieces of the siding are damaged or have cracks. Cracks are usually caused by poor installation and should be sealed to prevent water intrusion. I recommend repair by a qualified professional.

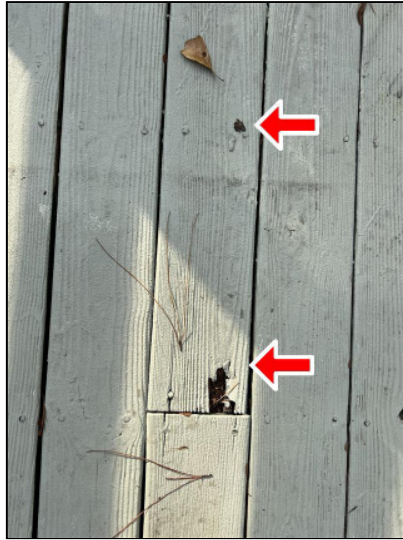
2.3 Item 2(Picture)

**2.3** Several boards on the back deck have wood rot. I recommend repair by a qualified professional.

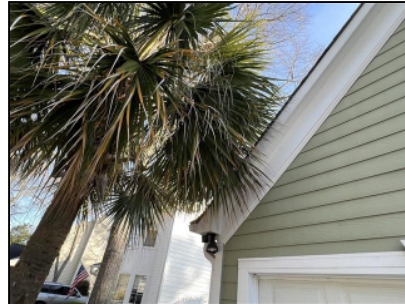
2.4 Item 1(Picture)

**2.4 (1)** The palmetto tree next to the garage is in contact with the roof and siding. The branches can damage the shingles and siding. I recommend having the trimmed away from the house.

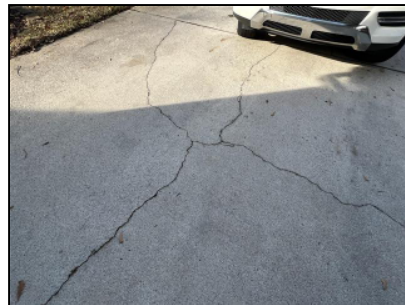
2.4 Item 2(Picture)

**2.4 (2)** The driveway is showing signs of settlement cracks. The most common reasons for settlement cracks in the driveway are settlement, shrinking, improper installation, and poor drainage. Small cracks are common and could be nothing to worry about. However, I recommend monitoring the floor, and if the cracks become bigger, I recommend repair by a qualified professional.

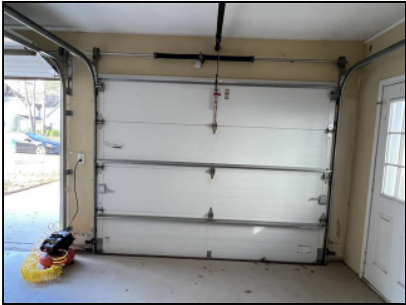
3.5 Item 1(Picture)

**3.5** The sensors are in place on the garage doors and will reverse when the sensor is blocked. However, the garage door on the right will not reverse when met with resistance. This is a safety issue as the weight and pressure involved in closing a garage door can cause serious injury to someone in the path of the door, especially children. I recommend repair by a qualified professional.

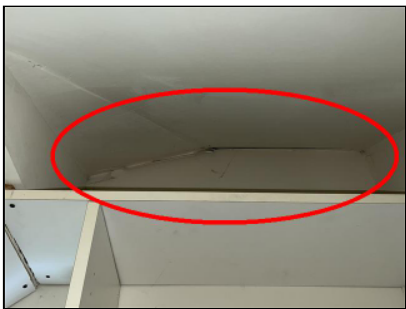
4.0 Item 2(Picture)

**4.0** There are a few settlement cracks on the ceiling in the FROG. There are several reasons for settlement cracks, with the most common being house settlement and the studs' movement due to expanding and contracting. This is considered cosmetic. Repair if desired.

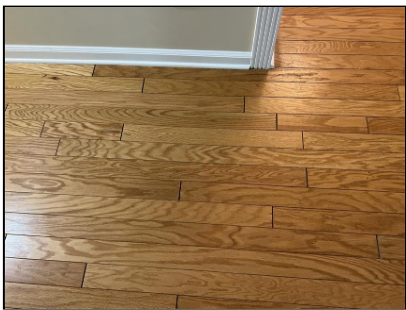
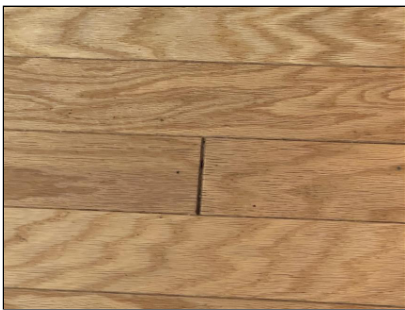
**4.2 (1)** The floors in the foyer and living room have wide gaps between several boards. Gaps in wood floors are normal and occur when the wood loses its moisture content. Several factors can be the cause, such as the flooring being installed during periods of higher humidity and during the winter; when the heat is on, the gaps appear. However, the large gaps are only showing up in theses two areas. I recommend further evaluation by a qualified flooring professional and correct it as needed.

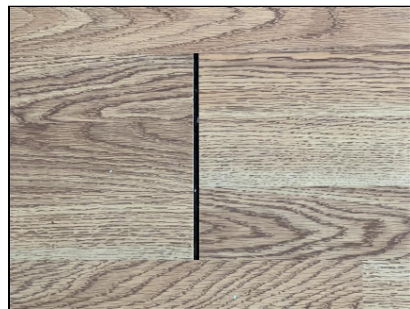
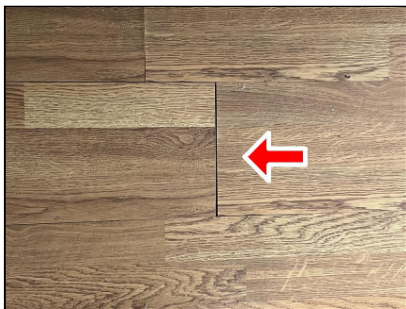
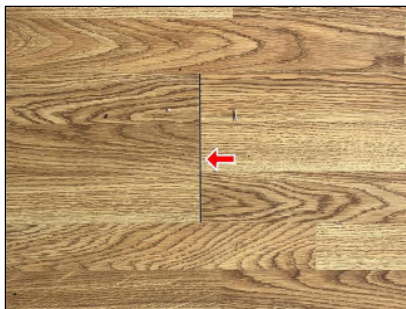
4.2 (2) There were a couple of significant gaps in the dining room flooring. However, I could close the gap by pushing on the flooring. This is a floating floor, and the gaps were probably formed due to the weather change. If the gaps reappear, all you need to do is slide the floor to close the gap.

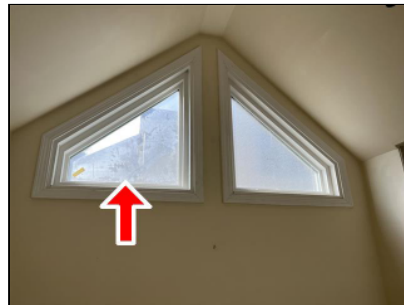
4.6 Item 1(Picture)

**4.6** The window in the master bathroom has lost the gas seal. A common problem with thermal windows is the seals around the edges of the glass fail, allowing the inert gas to escape and outside air to enter the space between the glass panes. As a result, moisture in the infiltrating air can condense when conditions are right, causing the glass to develop hazy foggiess. I recommend repair by a qualified professional.

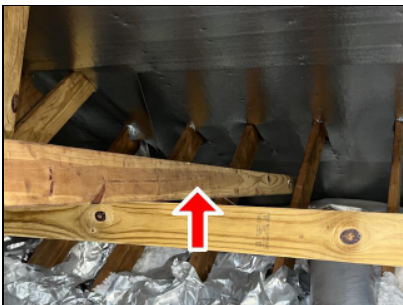
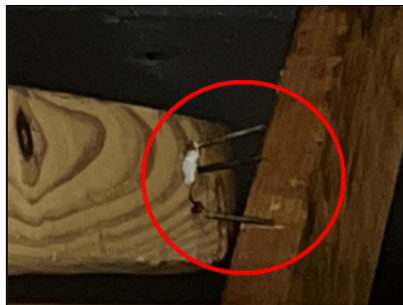
**5.5 (2)** One of the cross beams in the attic has pulled out and is no longer nailed in. I recommend repair by a qualified professional.

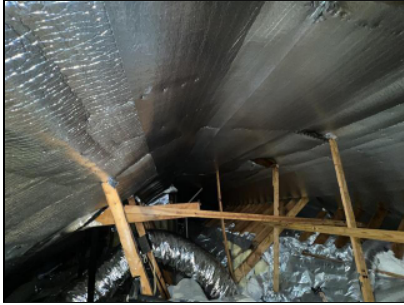
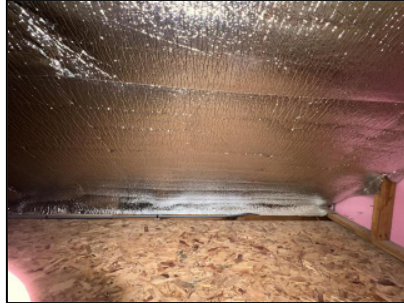
**5.5 (3)** The roof structure in the attic of home is covered with foil insulation and structural members are not visible. No obvious problems discovered. I could not see behind these coverings.

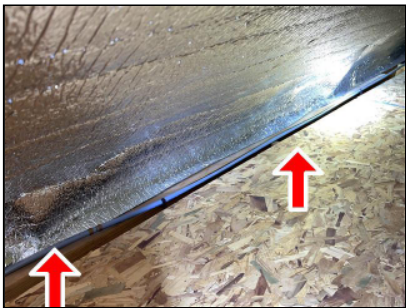
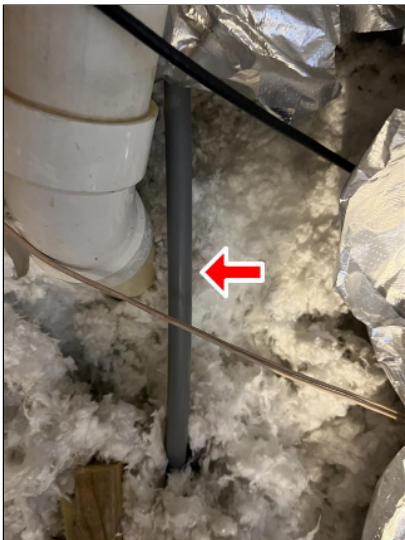
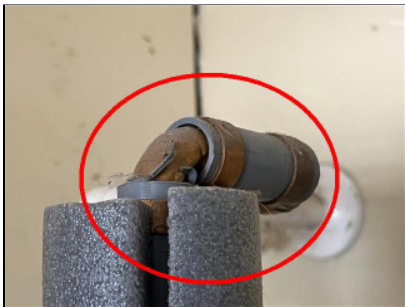
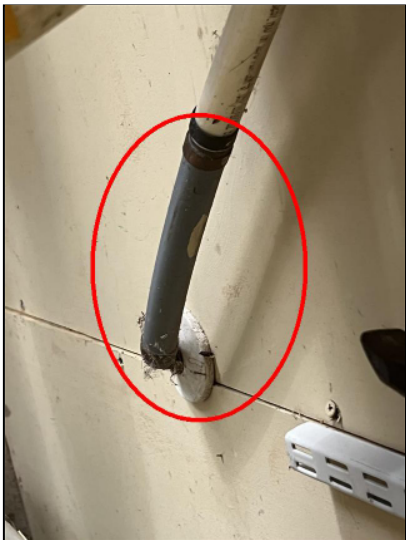
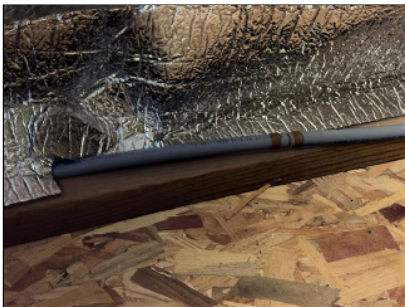
**6.1** (2) The plumbing supply in the home contains polybutylene (PB) with copper crimp rings. Polybutylene piping expands and contracts a good deal and the abrasive effects can be damaging. I did not observe any leaks at exposed joints I could see during the inspection. However, given the history of polybutylene piping I recommend you consider having a licensed plumber further evaluate the system.

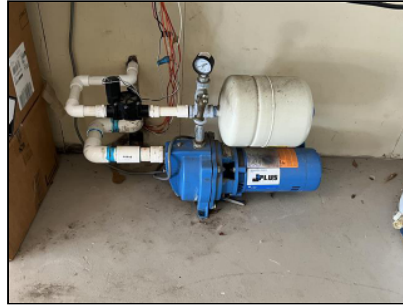
6.1 Item 8(Picture)

**6.1** (3) The house does have a pump for well water. Our company does not test or operate well pumps. I recommend having a well and pump company test and service the pump before use.

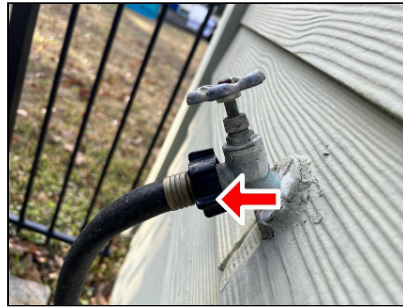
6.1 Item 9(Picture)

**6.1** (4) The outside hose bibs are missing backflow preventers. Without a backflow prevention device between your hose and hose bib (spigot or outside faucet), the contents of the hose and anything it is connected to can backflow into the piping system and could contaminate the drinking water. I recommend adding backflow preventers to the hose bibs.

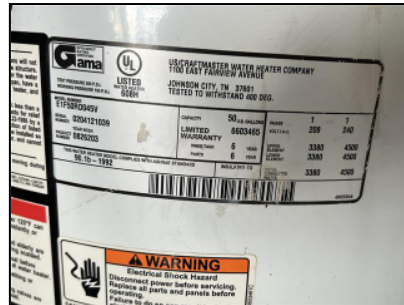
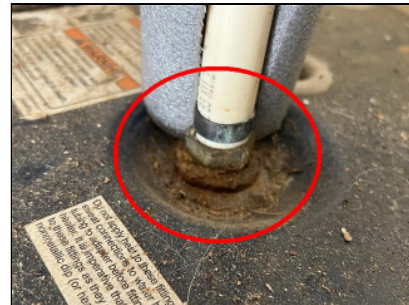
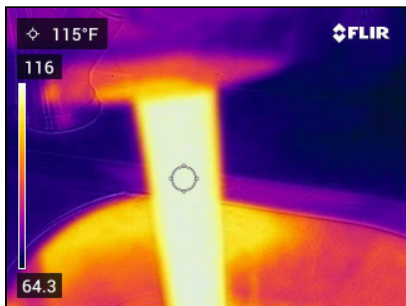
**6.2** The water heater's manufacture date is 2008. Based on the manufacturer's suggested service life, the life expectancy of a water heater is about 8 to 12 years. The water temperature was taken at the fixtures, and the highest temperature I could get was 115 degrees. This could be as simple as they have the temperature turned down at the water heater. The EPA does recommend 120 degrees because it is hot enough to stop diseases and not hot enough to cause scalding. Additionally, the top connections are starting to rust. Once they rust, the connections could burst. Due to the age of the water heater, and the rust, I would recommend replacing the water heater.

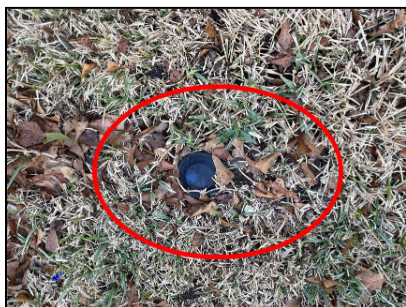
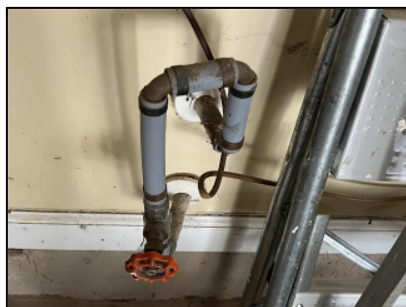
**6.3** The main shut off is located outside in the ground near the main road. There is an additional shut off located in the garage.

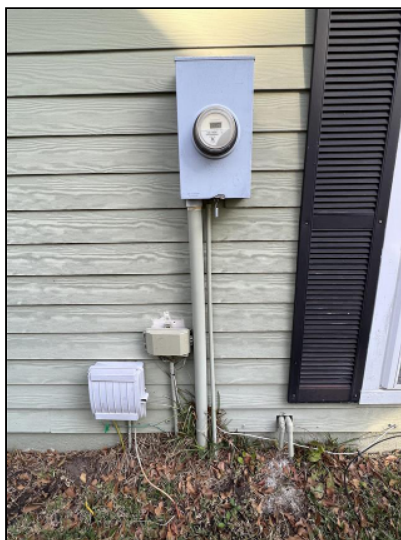
7.0 Item 1(Picture)

**7.0** The main service entrance is located at the side of the home.

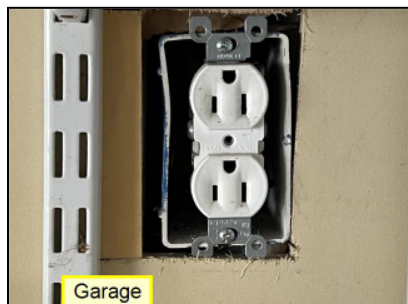
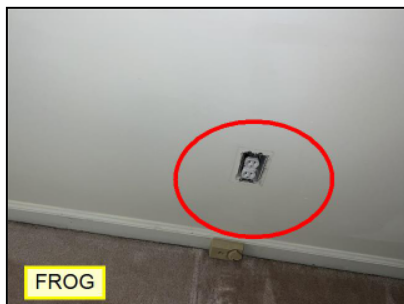
**7.3 (1)** There are two outlet covers missing. Missing outlet covers are a safety hazard. I recommend adding outlet covers.

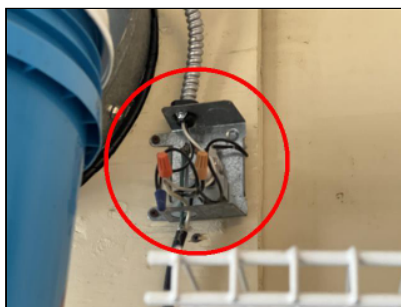
7.3 Item 3(Picture)

**7.3 (2)** The fan in the garage is missing the junction box, exposing the wires. Exposed wires are a safety hazard. I recommend repair by a qualified professional.

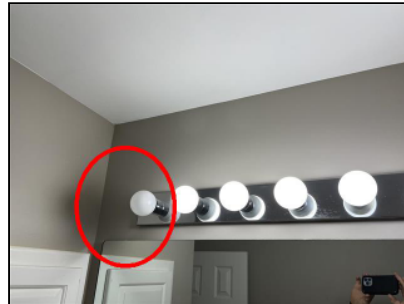
7.3 Item 6(Picture)

**7.3 (5)** The light in the guest bathroom is not working. This could be as simple as replacing a bulb. I recommend replacing the bulb. If that does not fix the issue, I recommend further evaluation by a qualified professional and correct as needed.

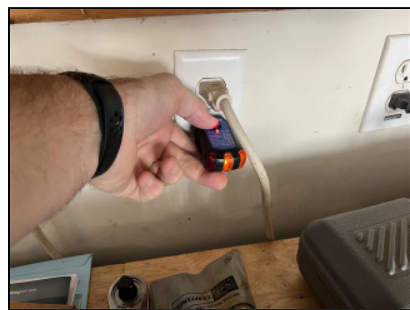
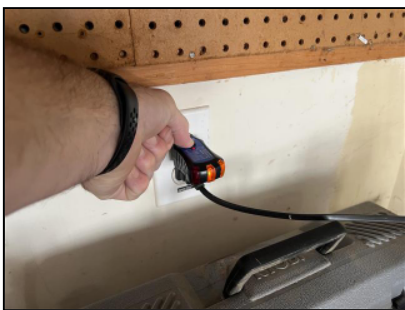
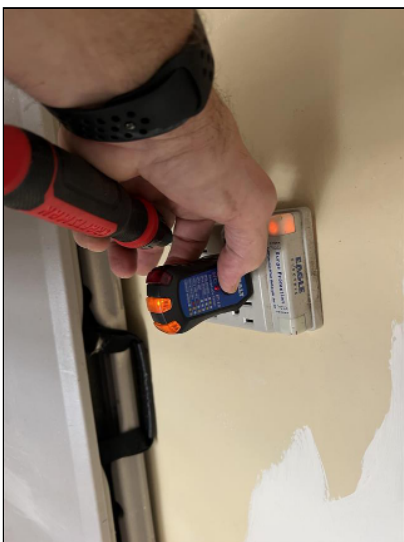
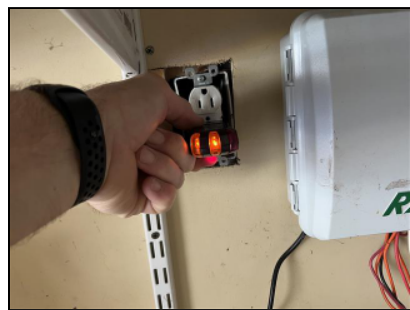
**7.5** Several of the outlets in the garage are not GFCI-protected. This is due to the age of the house. As an upgrade, I

recommend adding GFCI-protected outlets to the garage.

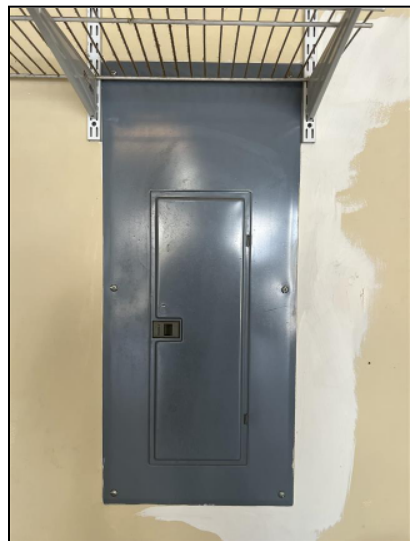
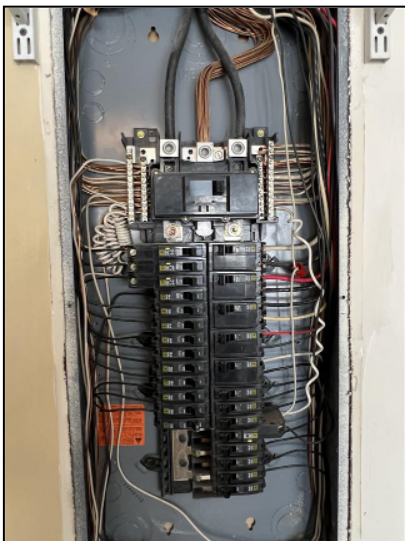
**7.7** The main distribution panel is located in the garage. I removed the cover of the distribution panel. No obvious problems were observed.

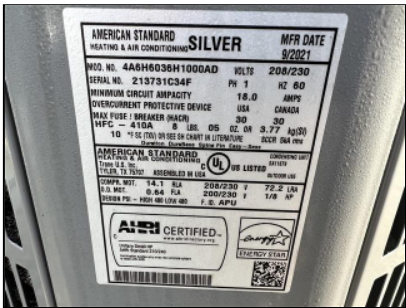
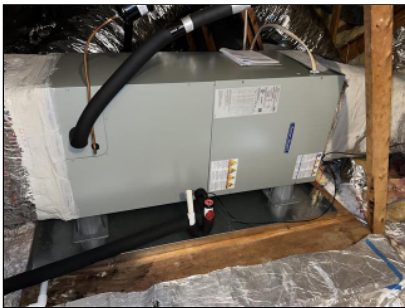
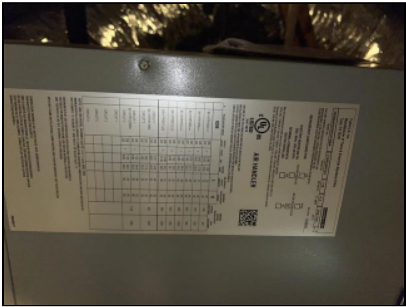
**8.8 (1)** The manufacture date of the HVAC is 2021. The average life expectancy of an air conditioner or heat pump in South Carolina is 15-20 years. However, attempts were made to turn on the HVAC to test the air conditioning, but it would not turn on. I recommend further evaluation by a qualified professional and correct it as needed.

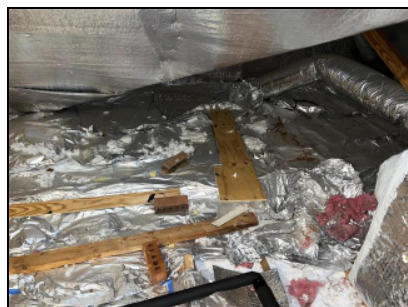
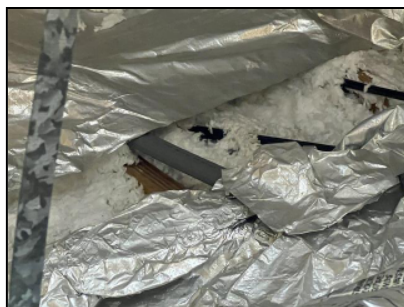
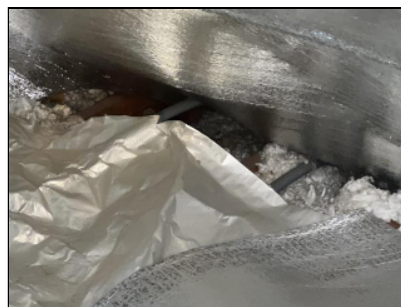
**9.0** I could not inspect the insulation due to the foil material installed in the attic.

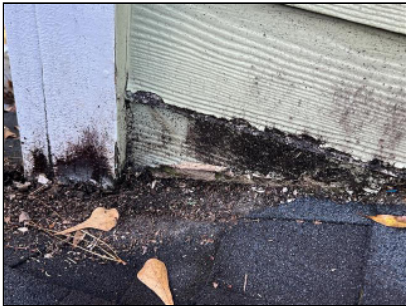
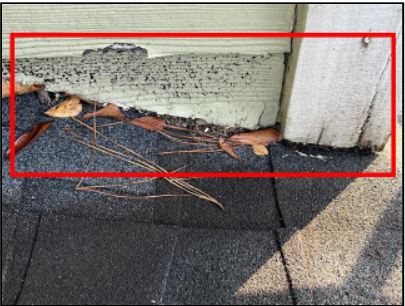
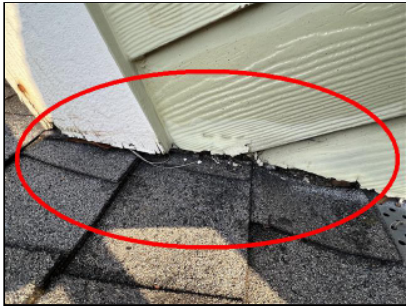
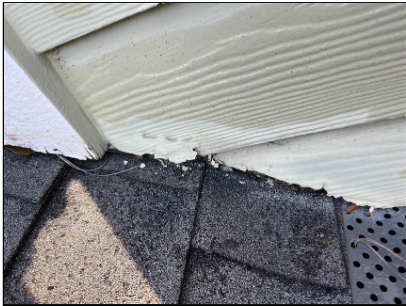
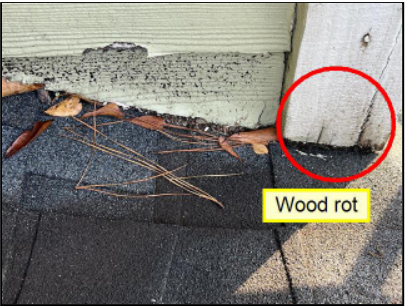
The base of the chimney, around the cricket flashing, has severe moisture damage. In addition, there is wood rot on the trim, and the siding has moisture damage. It appears this area holds water, and the cricket flashing may need to be larger, or another flashing may need to be installed. I recommend further evaluation by a qualified professional and correct it as needed.

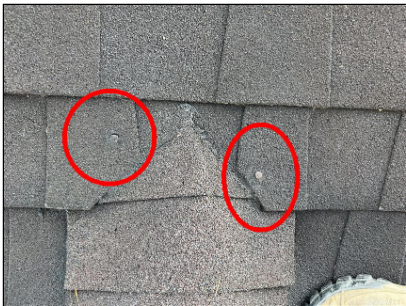
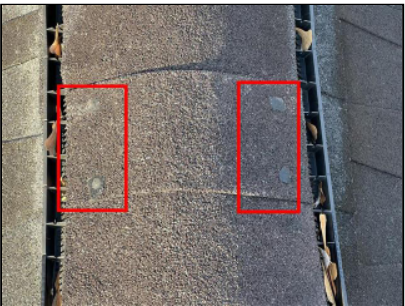
The nail heads on the ridge caps are exposed. Exposed nail heads can increase the chance of water penetration into the house. I recommend having the nail heads sealed with a roof sealant.

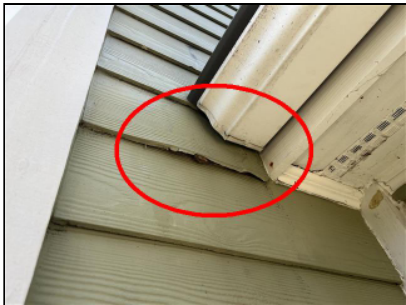
2.0 Item 1(Picture)

(1) There is moisture damage on the siding below the gutter on the chimney. The damage is most likely caused by water overflowing the gutters. I recommend further evaluation by a qualified professional and correct it as needed.

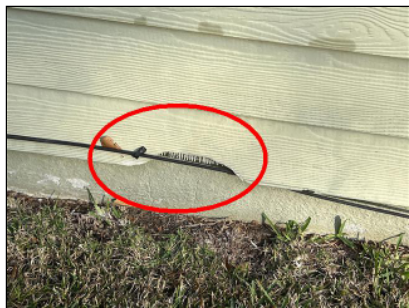
2.0 Item 4(Picture)

(3) Several pieces of the siding are damaged or have cracks. Cracks are usually caused by poor installation and should be sealed to prevent water intrusion. I recommend repair by a qualified professional.

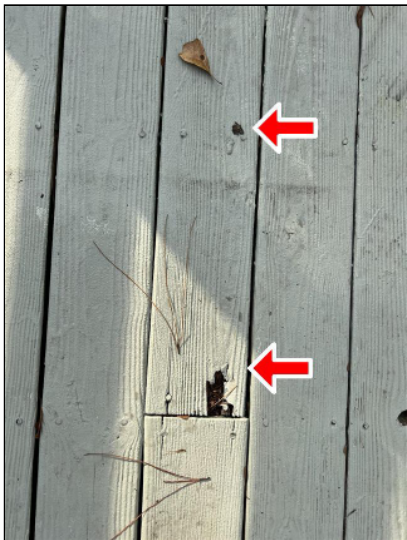
2.3 Item 2(Picture)

Several boards on the back deck have wood rot. I recommend repair by a qualified professional.

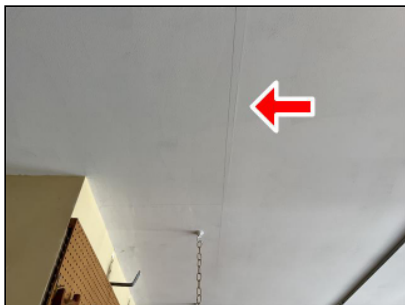
3.0 Item 1(Picture)

There is a settlement crack running through the garage ceiling. There are several reasons for settlement cracks, with the most common being house settlement and the studs' movement due to expanding and contracting. This is considered cosmetic. Repair if desired.

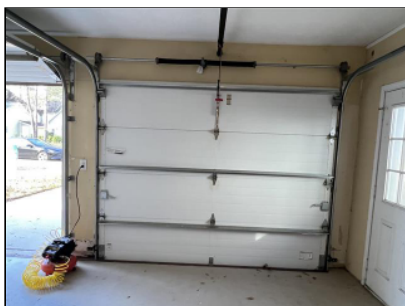
3.5 Item 1(Picture)

The sensors are in place on the garage doors and will reverse when the sensor is blocked. However, the garage door on the right will not reverse when met with resistance. This is a safety issue as the weight and pressure involved in closing a garage door can cause serious injury to someone in the path of the door, especially children. I recommend repair by a qualified professional.

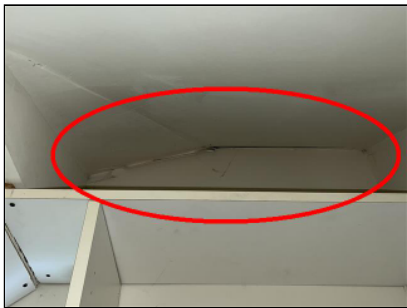
4.0 Item 2(Picture)

There are a few settlement cracks on the ceiling in the FROG. There are several reasons for settlement cracks, with the most common being house settlement and the studs' movement due to expanding and contracting. This is considered cosmetic. Repair if desired.

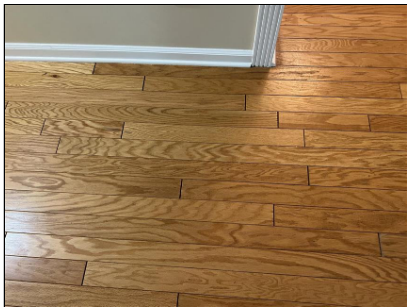
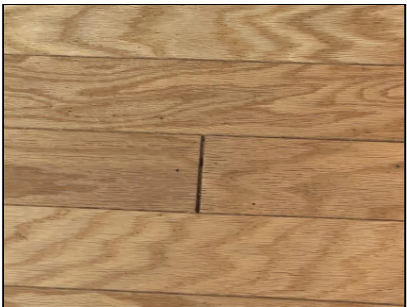
(1) The floors in the foyer and living room have wide gaps between several boards. Gaps in wood floors are normal and occur when the wood loses its moisture content. Several factors can be the cause, such as the flooring being installed during periods of higher humidity and during the winter; when the heat is on, the gaps appear. However, the large gaps are only showing up in these two areas. I recommend further evaluation by a qualified flooring professional and correct it as needed.

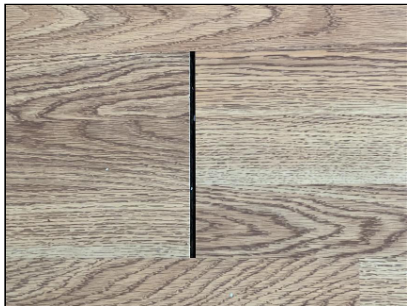
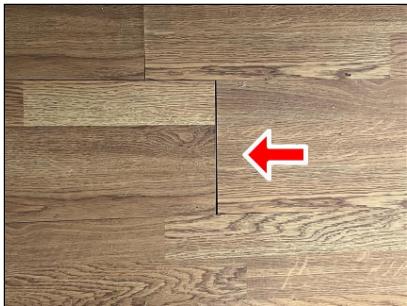
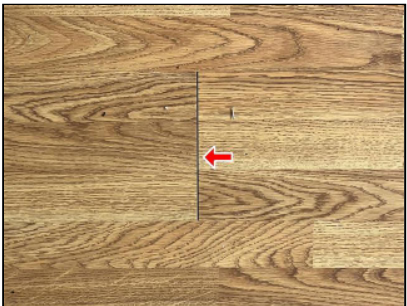
(2) There were a couple of significant gaps in the dining room flooring. However, I could close the gap by pushing on the flooring. This is a floating floor, and the gaps were probably formed due to the weather change. If the gaps reappear, all you need to do is slide the floor to close the gap.

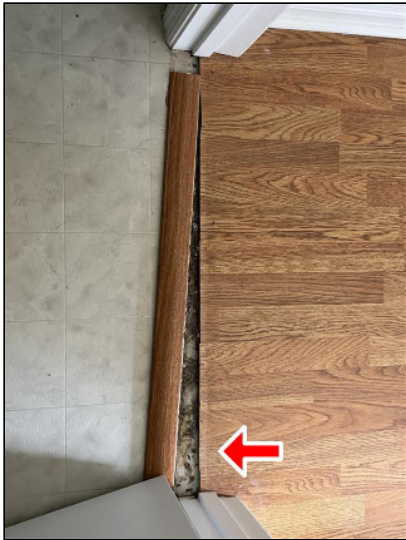
4.2 Item 7(Picture)

(3) The threshold to the laundry room is not attached. I recommend repair by a qualified professional.

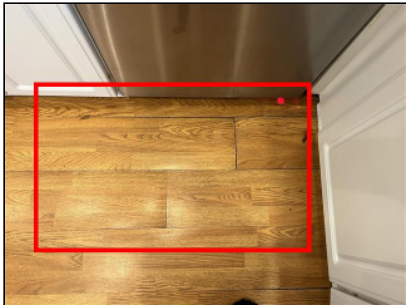
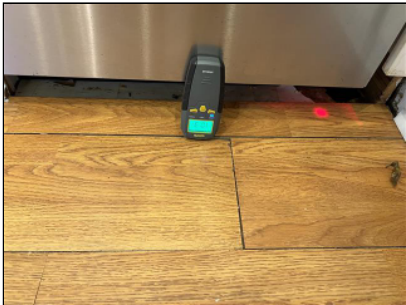
(4) The flooring in front of the dishwasher has moisture damage. At one time, the dishwasher leaked and damaged the floor. This section will most likely need to be replaced. I recommend repair by a qualified professional.

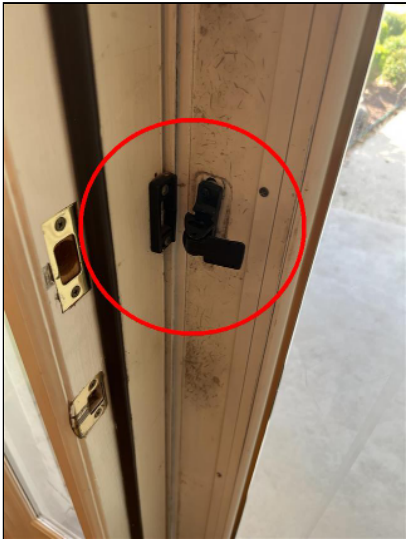
4.5 Item 2(Picture)

The front door is missing the pneumatic opener at the top, and the door handle does not engage the striker. I recommend repair by a qualified professional.

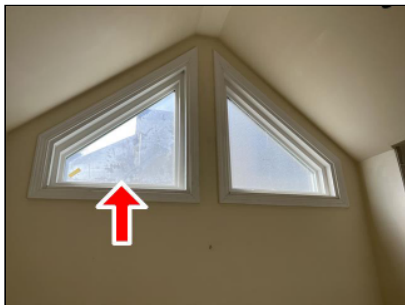
4.6 Item 1(Picture)

The window in the master bathroom has lost the gas seal. A common problem with thermal windows is the seals around the edges of the glass fail, allowing the inert gas to escape and outside air to enter the space between the glass panes. As a result, moisture in the infiltrating air can condense when conditions are right, causing the glass to develop hazy fogging. I recommend repair by a qualified professional.

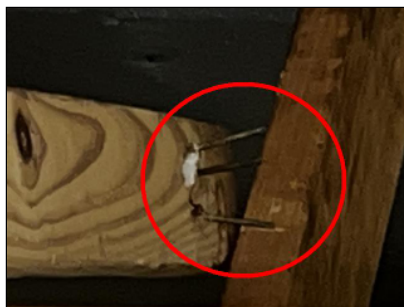
5.5 Item 4(Picture)

(2) One of the cross beams in the attic has pulled out and is no longer nailed in. I recommend repair by a qualified professional.

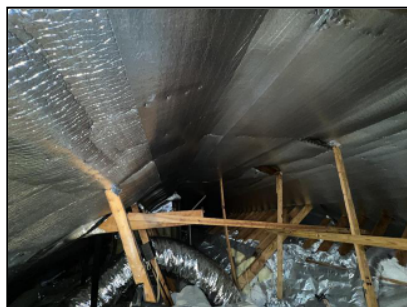
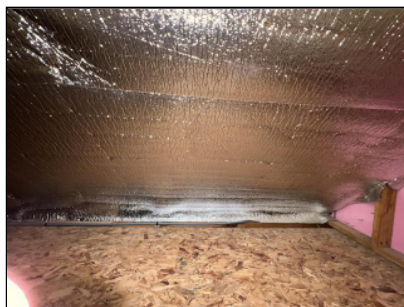
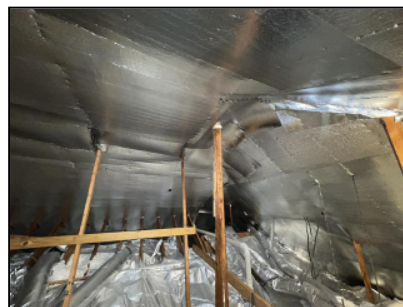
(3) The roof structure in the attic of home is covered with foil insulation and structural members are not visible. No obvious problems discovered. I could not see behind these coverings.

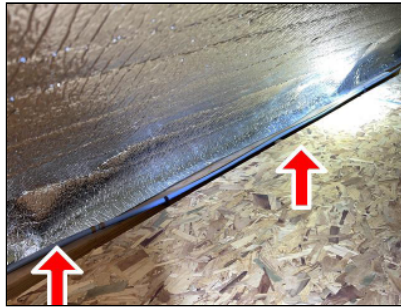
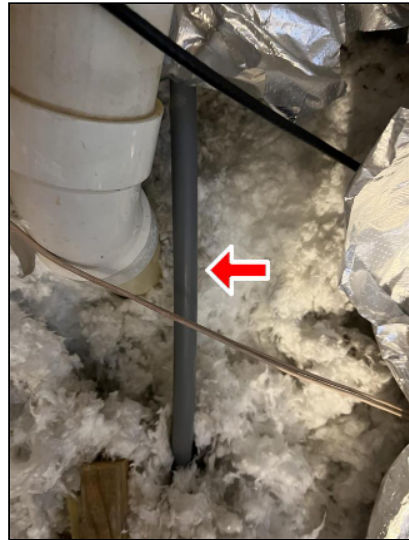
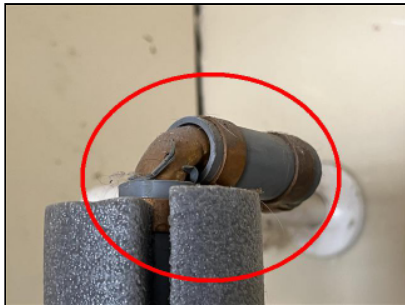
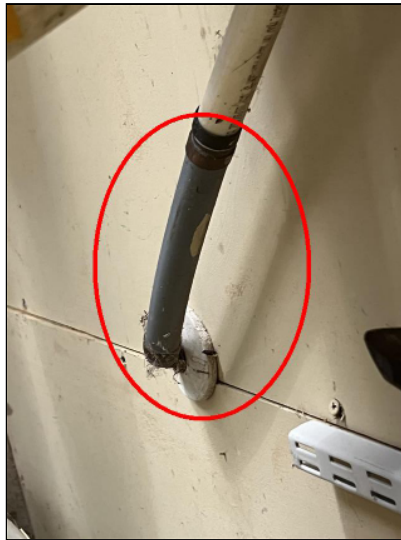
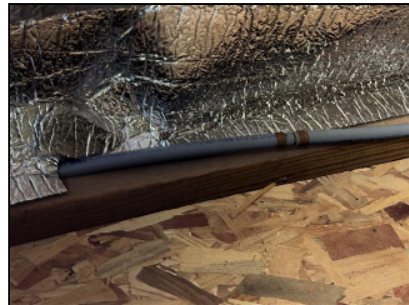
(2) The plumbing supply in the home contains polybutylene (PB) with copper crimp rings. Polybutylene piping expands and contracts a good deal and the abrasive effects can be damaging. I did not observe any leaks at exposed joints I could see during the inspection. However, given the history of polybutylene piping I recommend you consider having a licensed plumber further evaluate the system.

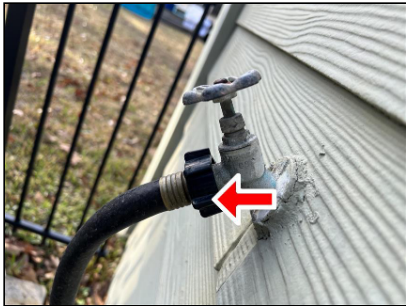
6.1 Item 9(Picture)

(4) The outside hose bibs are missing backflow preventers. Without a backflow prevention device between your hose and hose bib (spigot or outside faucet), the contents of the hose and anything it is connected to can backflow into the piping system and could contaminate the drinking water. I recommend adding backflow preventers to the hose bibs.

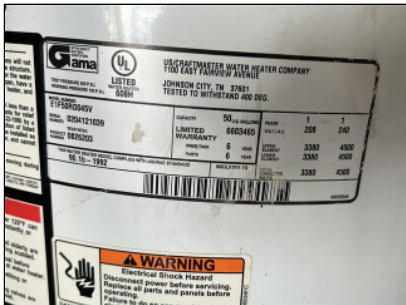
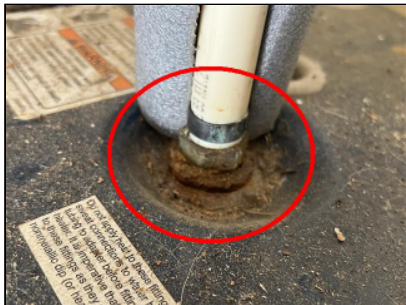
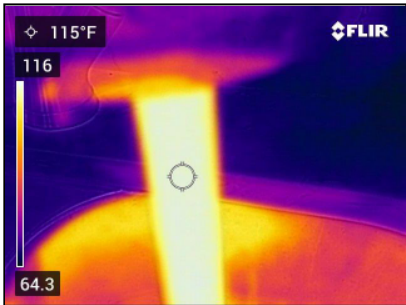
The water heater's manufacture date is 2008. Based on the manufacturer's suggested service life, the life expectancy of a water heater is about 8 to 12 years. The water temperature was taken at the fixtures, and the highest temperature I could get was 115 degrees. This could be a simple as they have the temperature turned down at the water heater. The EPA does recommend 120 degrees because it is hot enough to stop diseases and not hot enough to cause scalding. Additionally, the top connections are starting to rust. Once they rust, the connections could burst. Due to the age of the water heater, and the rust, I would recommend replacing the water heater.

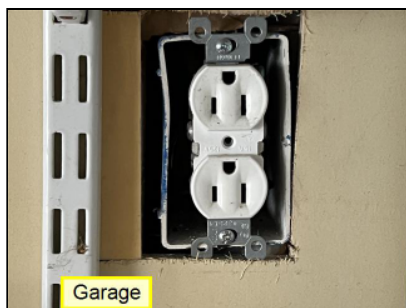
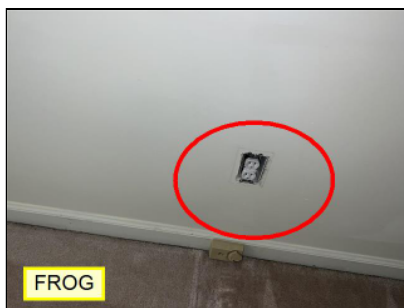
(1) There are two outlet covers missing. Missing outlet covers are a safety hazard. I recommend adding outlet

covers.

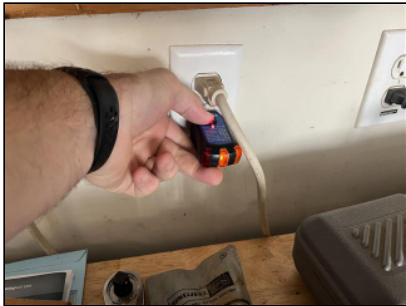
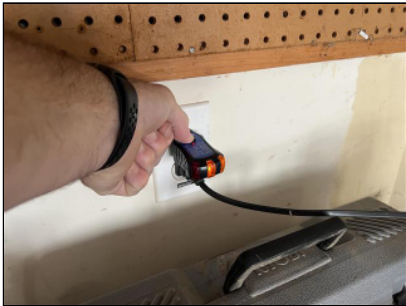
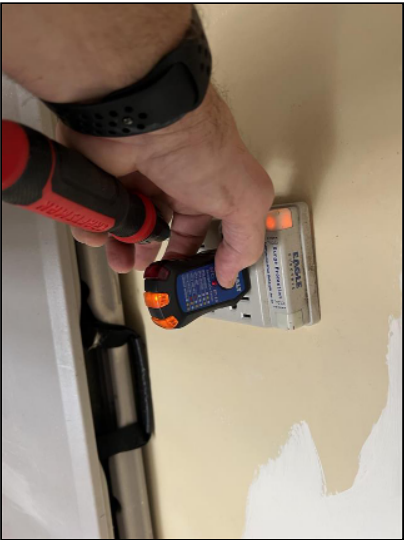
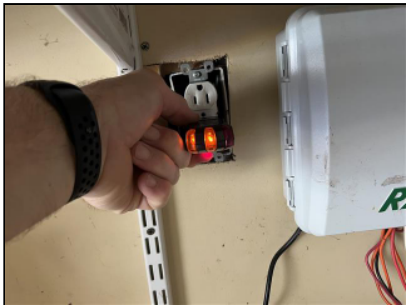
Several of the outlets in the garage are not GFCI-protected. This is due to the age of the house. As an upgrade, I recommend adding GFCI-protected outlets to the garage.

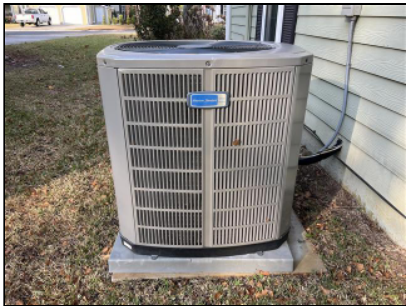
8.8 Item 1(Picture)

(1) The manufacture date of the HVAC is 2021. The average life expectancy of an air conditioner or heat pump in South Carolina is 15-20 years. However, attempts were made to turn on the HVAC to test the air conditioning, but it would not turn on. I recommend further evaluation by a qualified professional and correct it as needed.

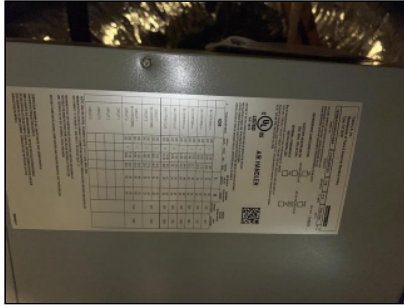
8.8 Item 4(Picture)

(2) The air handler in the attic is missing the seismic straps. Seismic straps are designed to hold the air handler in place during an earthquake so no damage is done to the lines. I recommend adding seismic straps and securing the air handler to the structure.
